INFRARED DIAGNOSTIC REPORT

ABLE INSPECTION COMPANY

Client has experienced water leakage on ceiling of Family room from master shower above. Client had this shower renovated with a new "pan membrane" approximately two years ago. Client desires to know what is cause of this leak and in addition a "slow drain" during use of this shower.

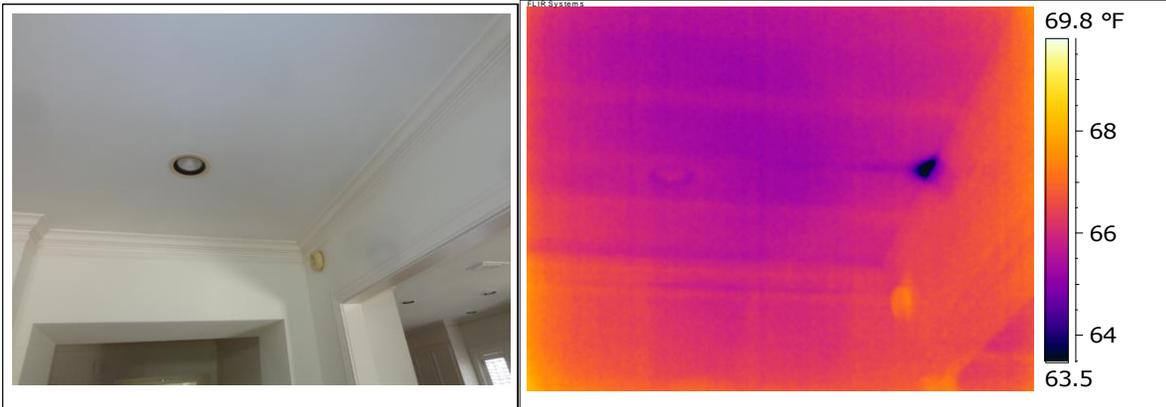
During initial examination of the family room wall, inspector located a small moist water anomaly on ceiling and wall between family room and breakfast room. Inspector operated 2nd level Master shower fixture in normal mode and water "back-up" quickly due to a "restricted drain".

Image taken during initial visit with moisture on upper right ceiling of family room under master shower above

- the master shower tile be removed along the floor, the curb, the bench and 3-4 tiles from bottom at perimeter walls
- examine the installation of this shower pan (commonly vinyl) especially at "corners" and examine for the installation of premade "corner-stops"
- Examine the bench and type of frame material used (wood not favorable)
- Due to a restricted drain system, the drain piping should also be "completely removed" especially the P trap assembly and any other bends that can cause restrictions
- Choice of shower pan membranes such as vinyl, lead and others are available and should be carefully reviewed by homeowner

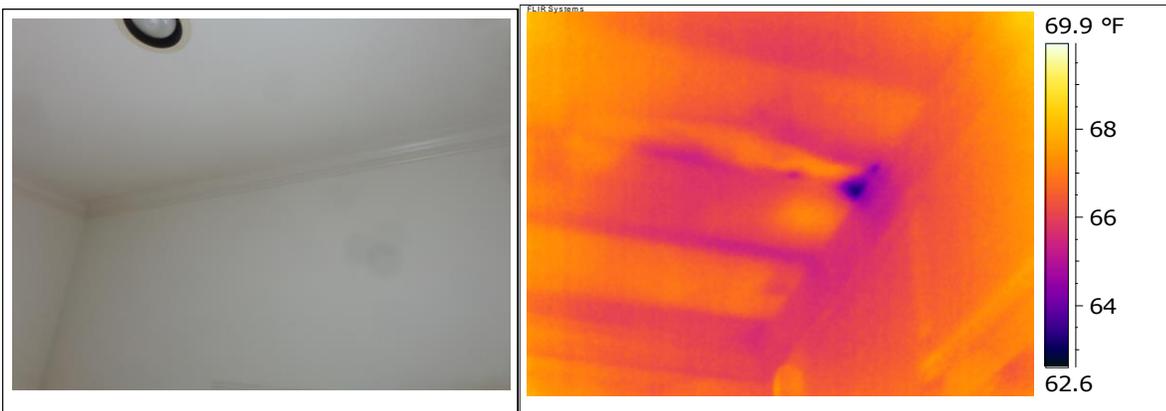
There was some minor amount of additional moisture detected on ceiling from the standing water in this shower. Inspector covered drain and allowed no more than 1" of water to stand in this shower to allow a "head test" to this shower.

Image of additional moisture on ceiling of family room with some restricted water in master shower

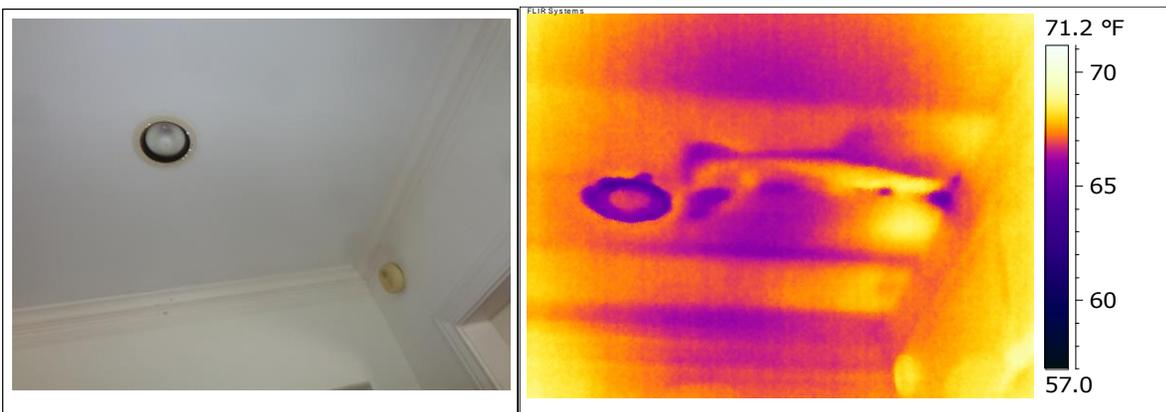
In approximate 20 minutes water started dripping out of light fixture onto the hardwood floors, confirming a "defective" shower pan.

Image of excessive moisture on ceiling after 20 minute water head test to the master shower and drippings of water off recess light

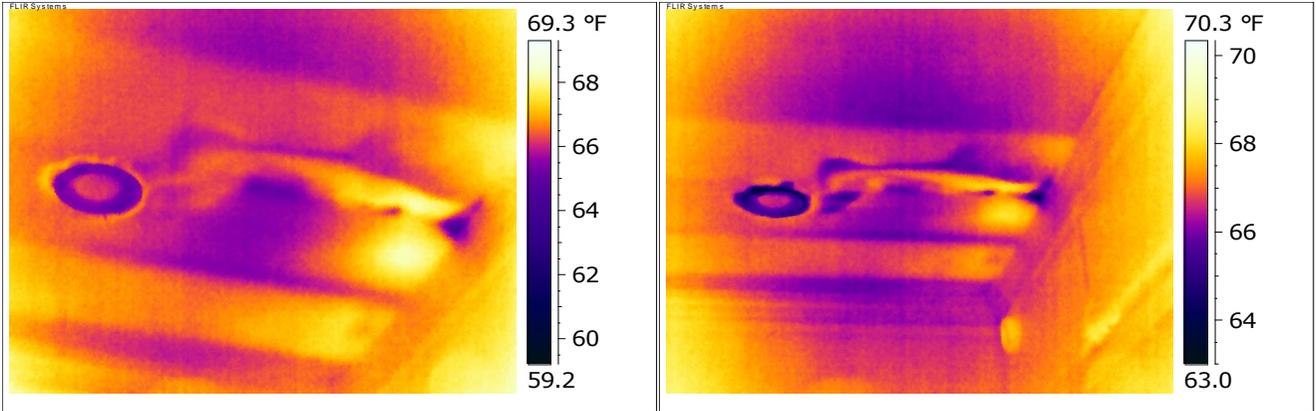
Additional images of moisture and water on ceiling under master shower after 20 minute head test

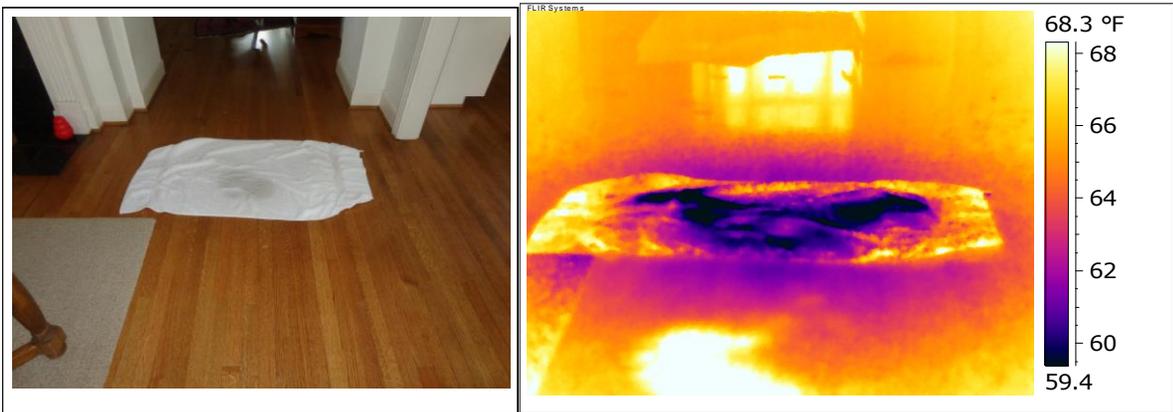
Image of water on towel on top of hardwood flooring from master shower leak

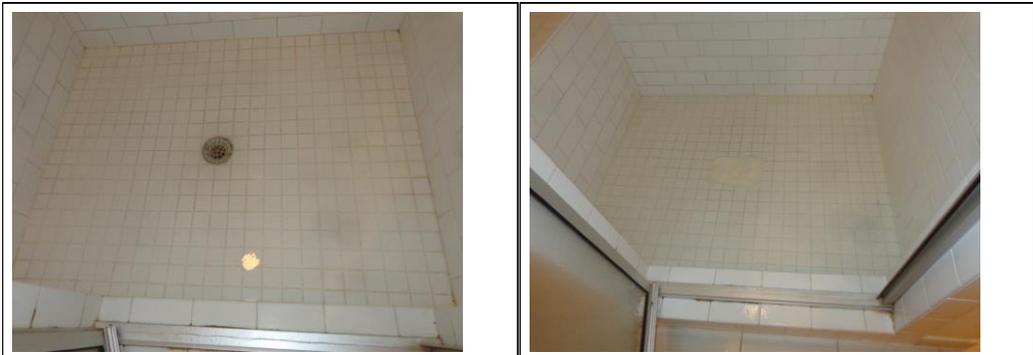
Restricted water at shower drain / water head test with covered drain
