**ABLE INSPECTIONS**  
*Inspecting Commercial Buildings Since 1976*  
**713 465-0000**

**CLIENT:** Judy Sample

Houston, TX

## **COMMERCIAL BUILDING DESCRIPTION w/FRONT OFFICE AND REAR WAREHOUSE ATTACHMENT**

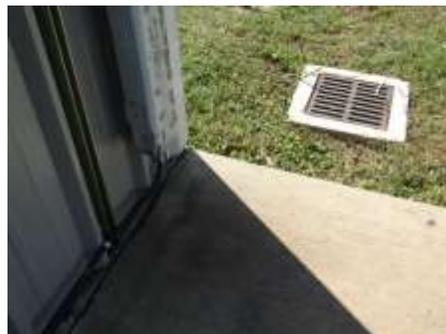
**(D)** Open and unused 4" drain pipe at west side flatwork,

**Open and unused 4" drain pipe at west side flatwork**

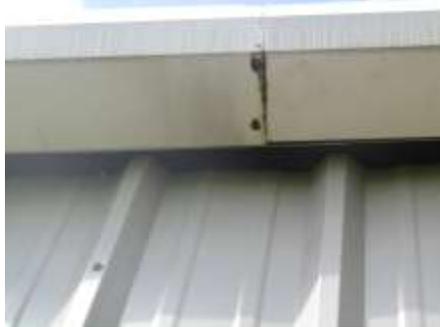
5. Multiple locations of stains and water drip leaks off of rain gutter joints connections located along east and west sides of building.
6. Remove the tree debris accumulation off of the roof and valleys, etc. to allow rainwater diversion (the condition of any covered roof material is unknown) – for the most part, at rear north area of building. Prune tree branches away from the roof to prevent damage to roofing material, rain gutters (if installed) and perimeter fascia material and to also reduce the opportunity for the infestation of pests, carpenter ants and other wood destroying insects – for the most part, at rear north area of building.

**Gutter joint leakage**

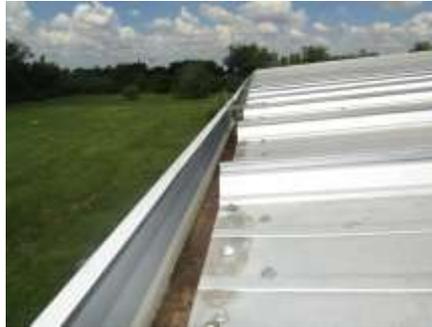
**Clean gutters**

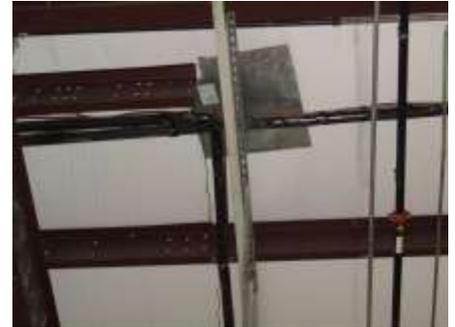
**Area of roof leak in warehouse**

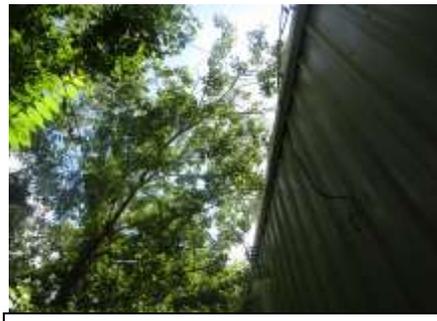
**Tree branches on rear building**

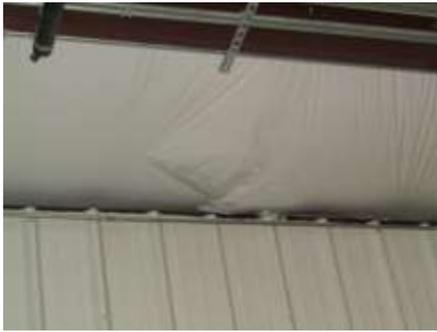
**Damaged insulation under east warehouse roof from water leakage**

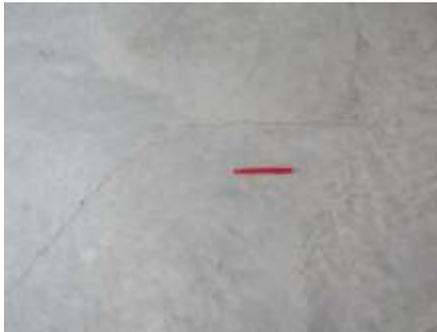
**Concrete temperature cracks in second level concrete**

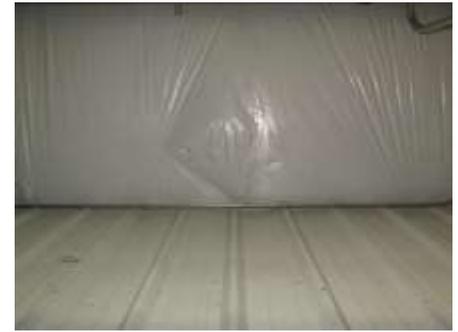
**Bubble in insulation from water and roof leak**

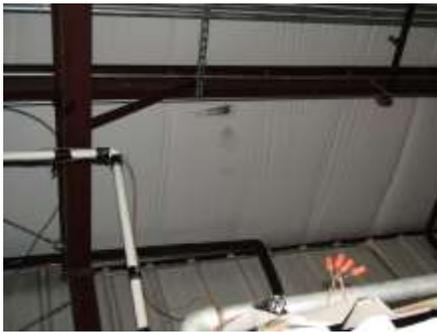
**Stained west side plastic insulation**

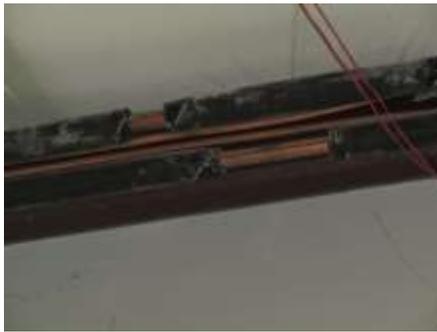
**HVAC refrigerant line gaps from missing insulation**

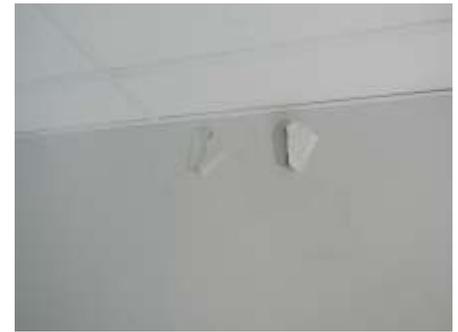
**Drywall damages in second level wall**

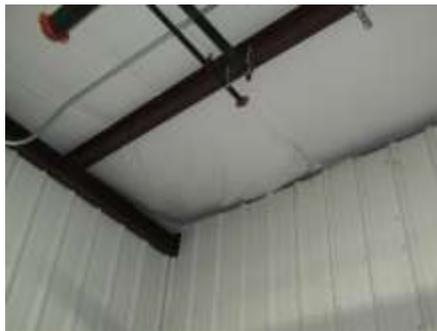
**Water damaged insulation at rear northeast corner of warehouse**

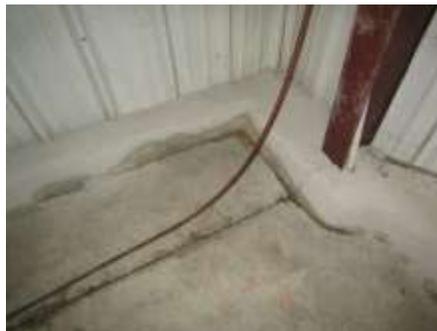
**Water stains on west side warehouse**

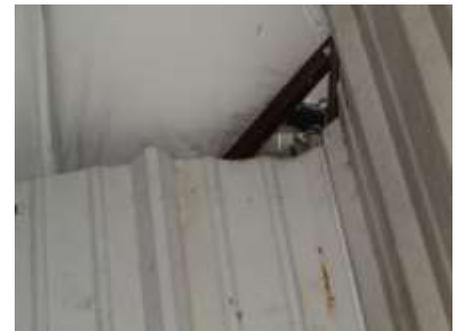
**Void at west side wall panel and roof**

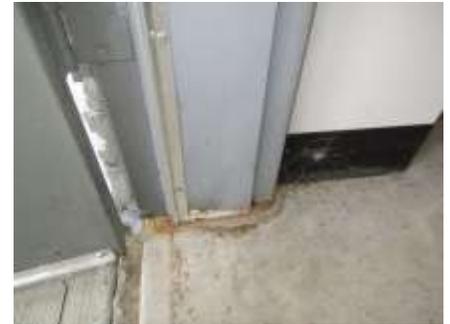
Water stains in front southwest single door

It is very important that a prudent building owner retain the services of a reputable and qualified contractor in the immediate future to determine the exact source of leaks, to examine all areas for hidden damages and to expose any possible mold/mildew and provide estimates for the appropriate repairs. Failure to respond to the conditions mentioned above, before the purchase of this property, commonly results in unanticipated, and often costly, repairs.

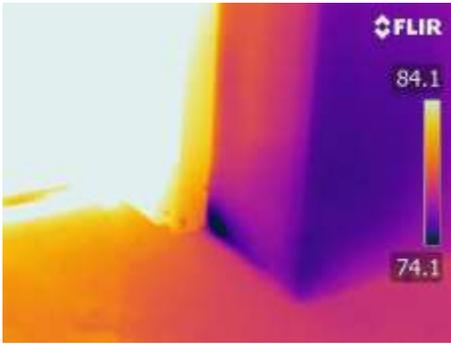
Water inside front southwest single door

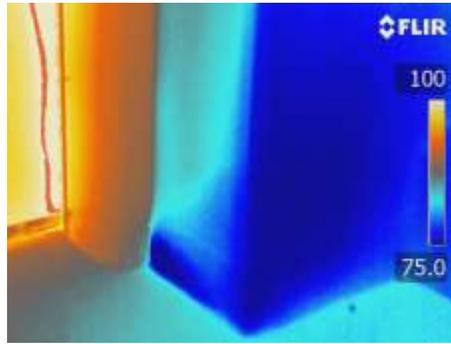
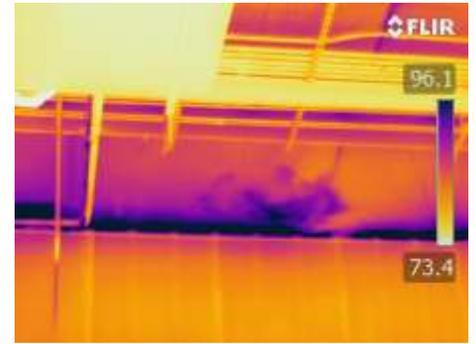
Water image in east warehouse on insulation under roof

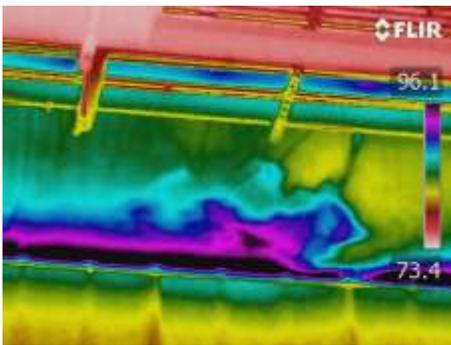
Water image in east warehouse on insulation under roof (same above)

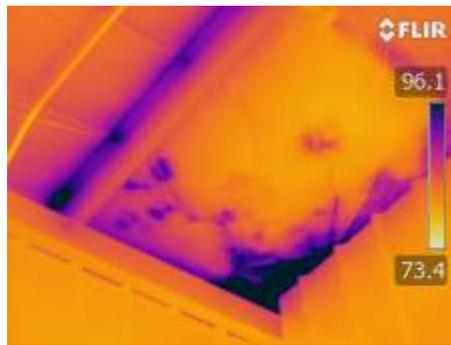
Water images on insulation at rear northeast corner

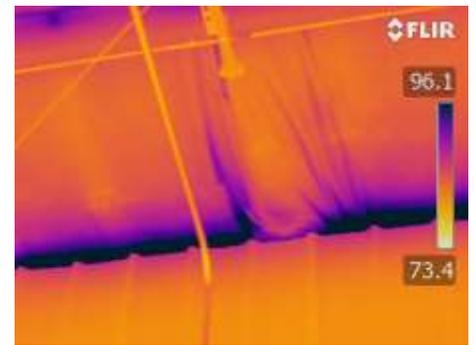
Image of bubble in insulation with suspect water

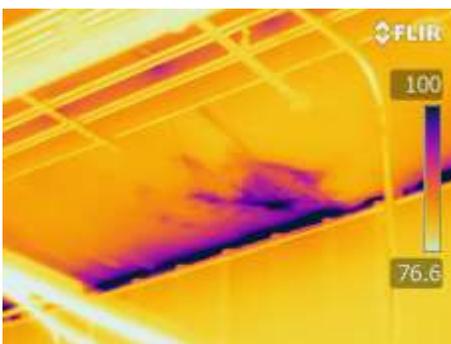
Another image of water in insulation at east area warehouse

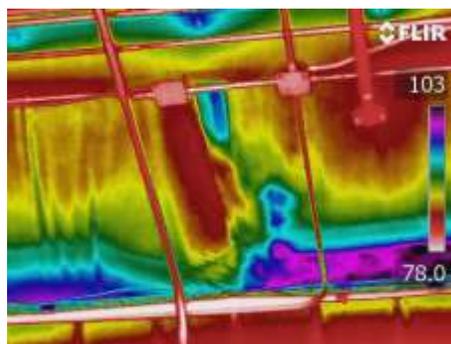
Images of water in insulation along west side warehouse

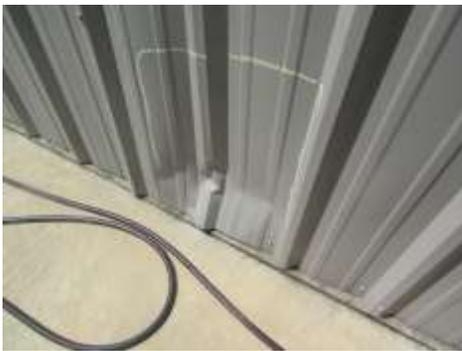
**Damaged east wall panel**

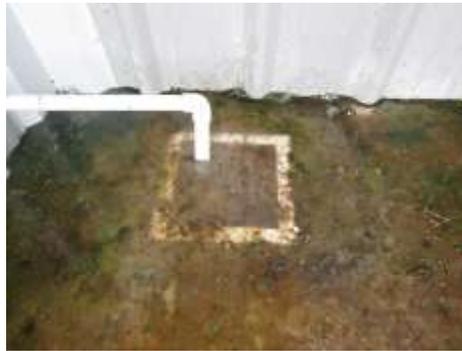
**Clogged east A/C drain basin**

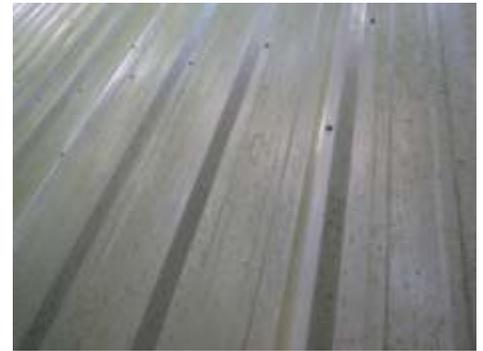
**Algae and vegetation stains on siding**

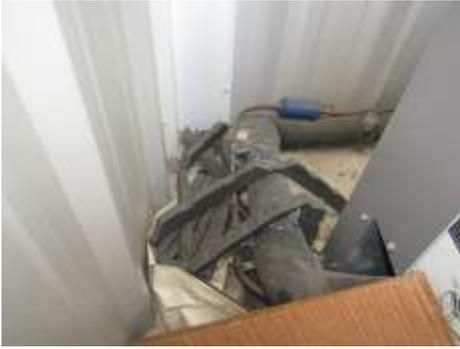
**Extra foam inserts for wall panels**

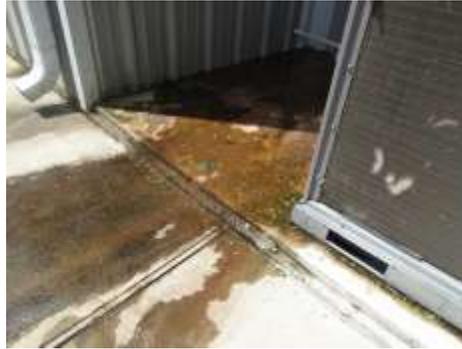
**Excessive algae and water from clogged east A/C drain basin**

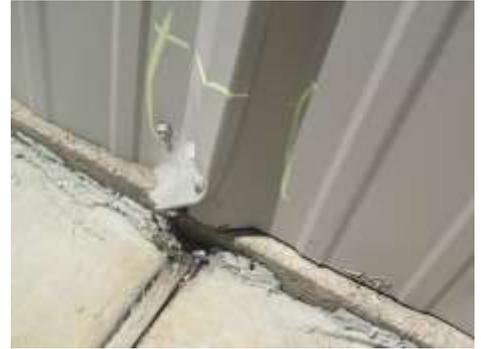
**Damaged east wall panels**

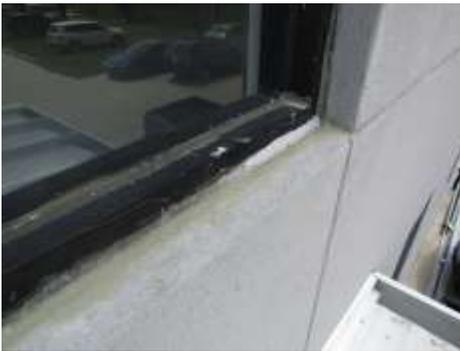
**Missing caulking at upper windows**

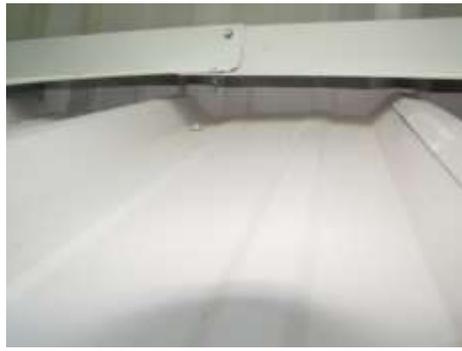
**Missing foam inserts for wall panels at A/C unit enclosures**

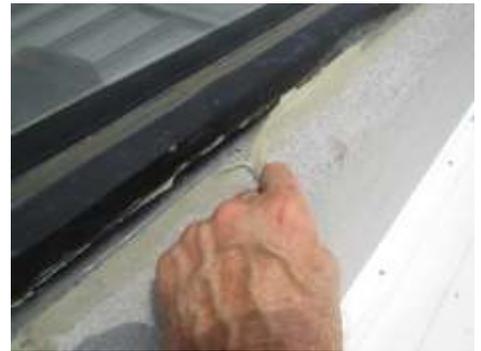
**Loose silicone caulk at upper large window**

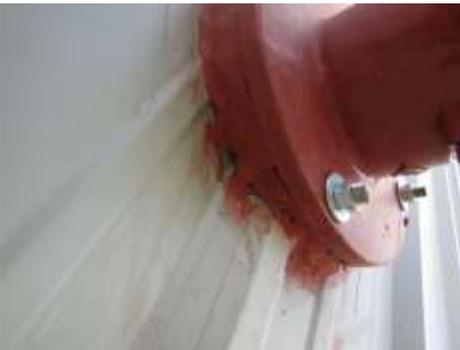
**Poor sealant at fire sprinkler valves in wall panel siding**

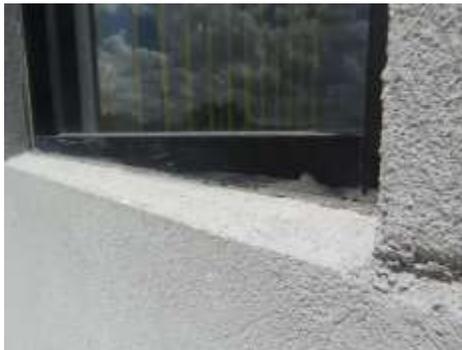
**Poor caulking at upper windows**

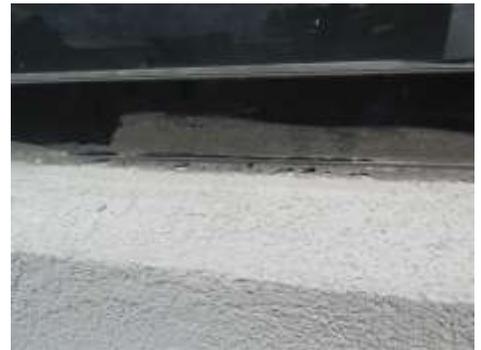
**Poor caulking at front upper windows**

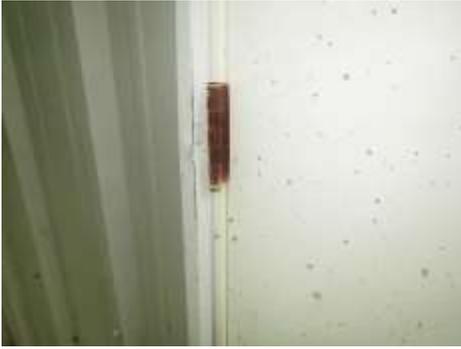
**Rusted rear door hinges**

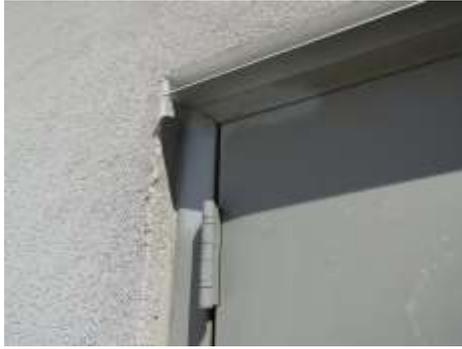
**Rust and incomplete painting of front metal door**

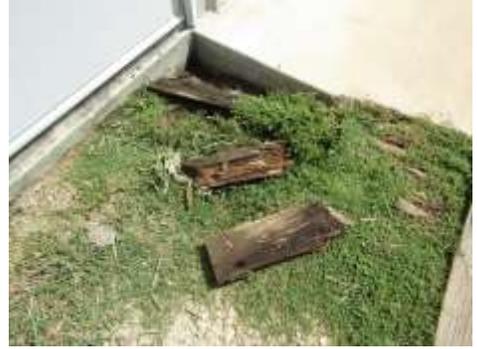
**Remove all wood debris close to building**

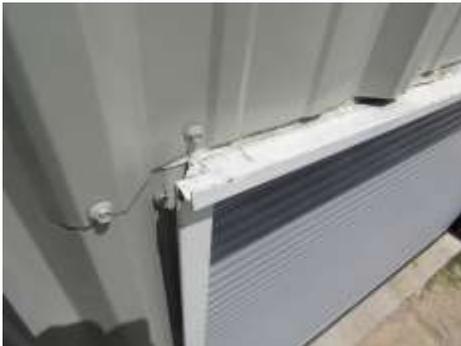
**Seal around large bay door and wall panels**

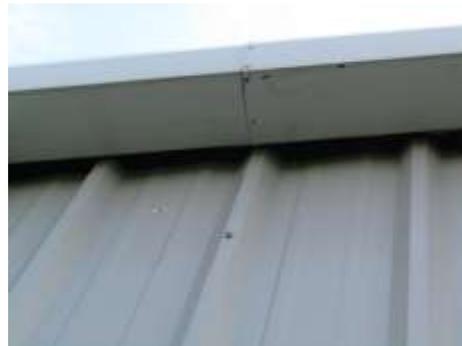
**Seal all gutter joints**

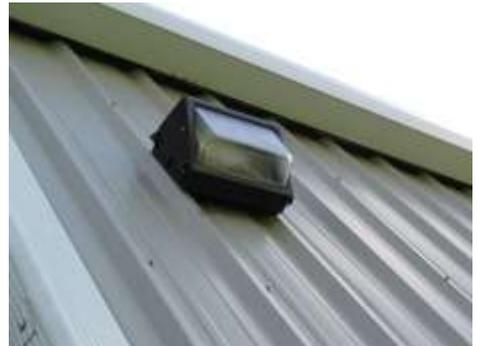
**Seal all exterior security lights**

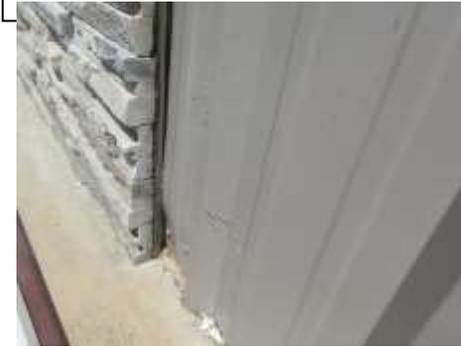
**Seal voids at front east stone and wall panel**

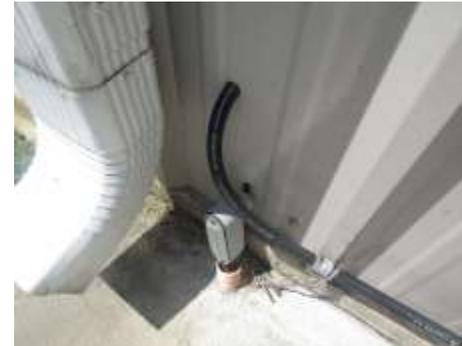
**Seal voids at east side electrical**

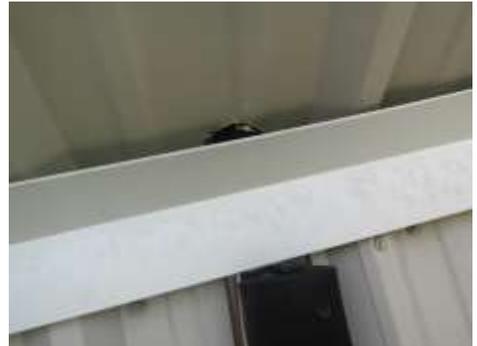
**Seal voids at A/C refrigerant lines in wall panels**

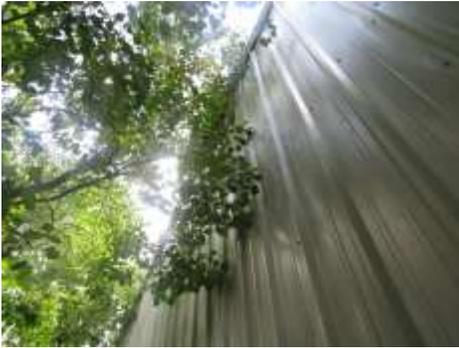
**Tree branches on rear wall siding**

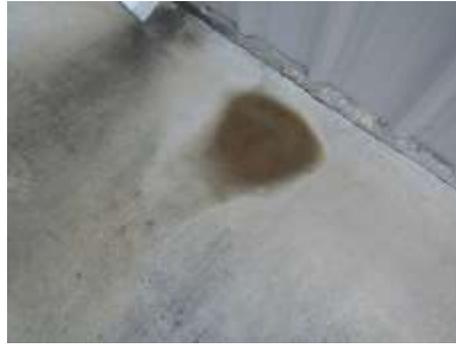
**Stained flatwork from gutter leakage**

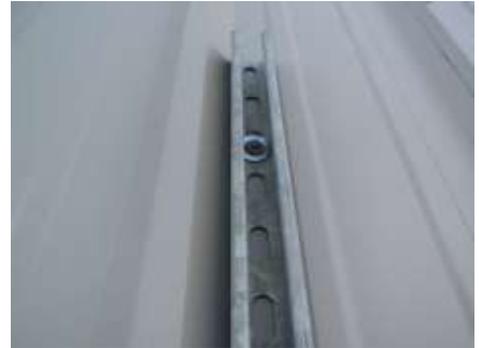
**Seal west side fasteners in siding**

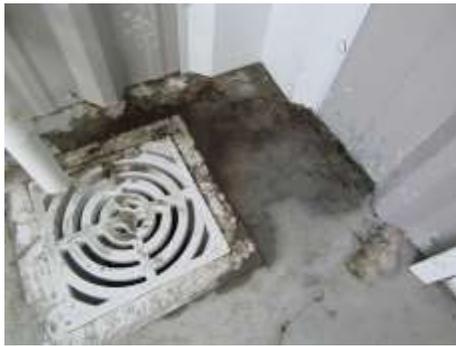
**Water leakage off west side A/C drain**

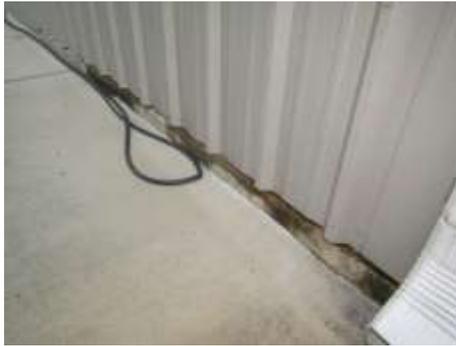
**Water leakage along west side building and wall panel**

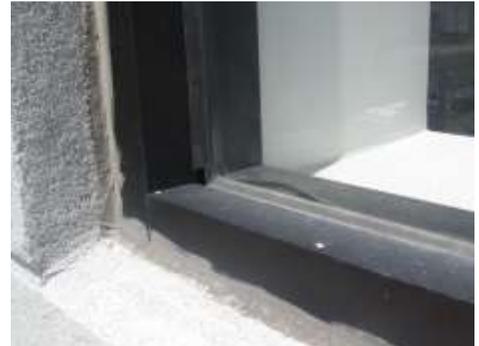
**Voids at upper window metal frames and gasket**

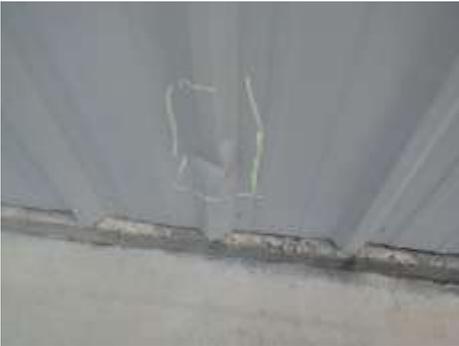
**Damaged west side wall panel**

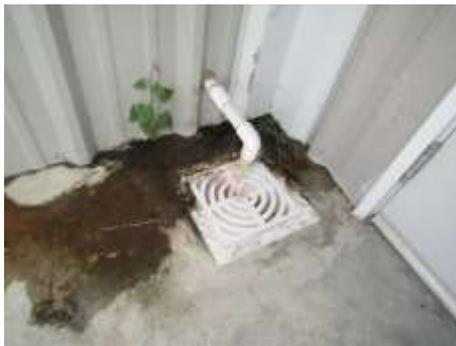
**Wet flatwork from poor A/C drain termination**

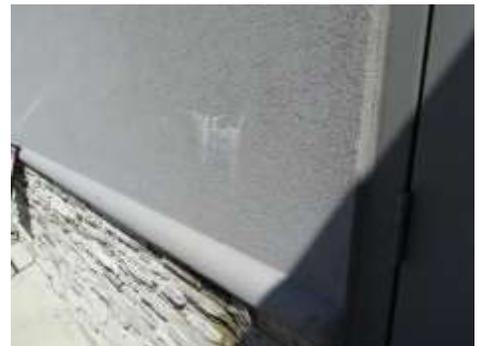
**Water stained EIFS stucco adjacent to front southwest door**

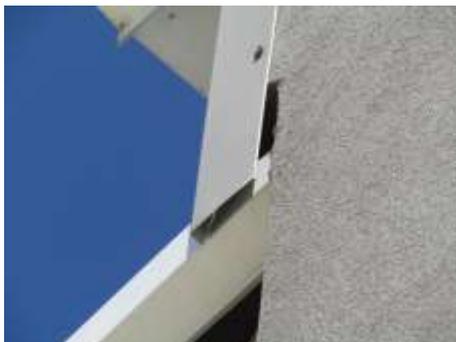
**Void at front west metal trim and EIFS stucco**

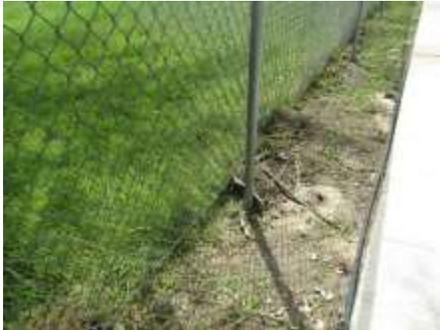
Loose east side fence

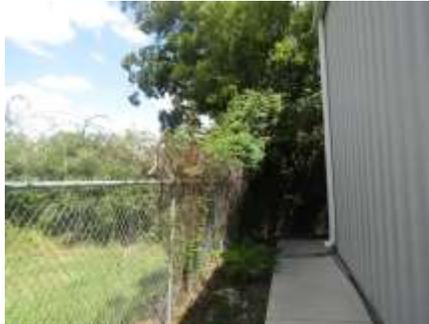
Excess ivy on fence

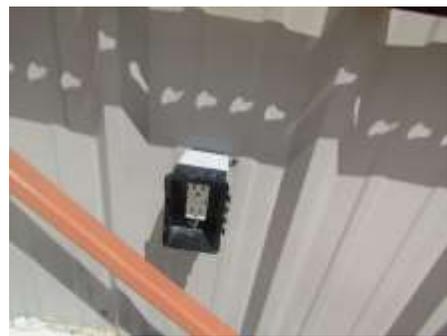
Plastic cover missing off front electrical outlet

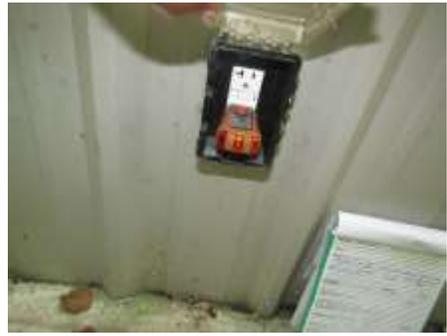
No power at rear north outlet

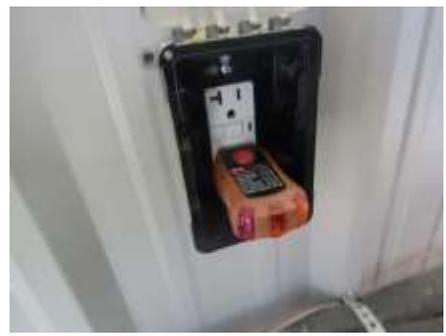
Exterior outlets with no power

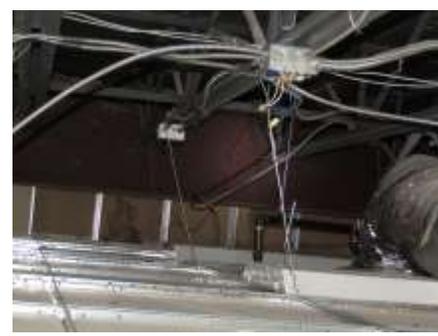
Missing cover on junction box above front office reception ceiling

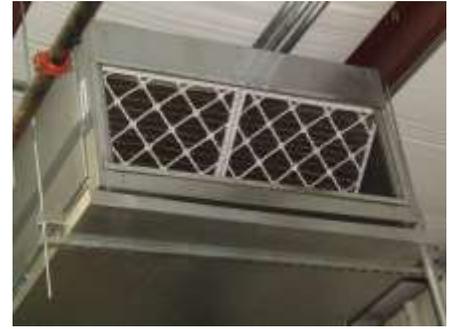
RETURN AIR: (D) Replace filters at all locations especially in warehouse areas that are discolored with residue accumulation.

Replace filters on all HVAC units in warehouse

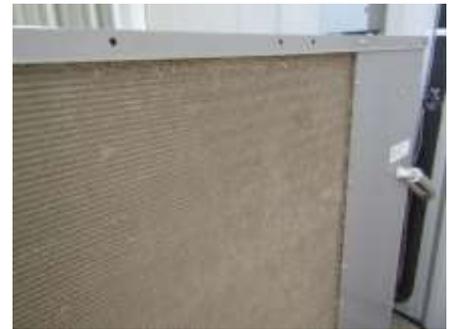
Clean coils of dust and debris

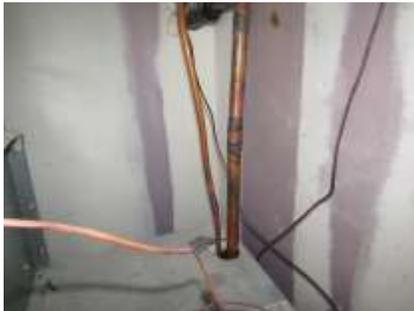
Missing insulation on second level west office refrigerant line

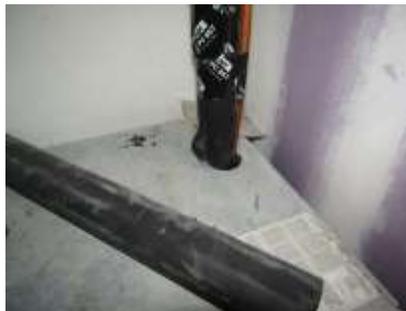
Air leaks at refrigerant lines in coil cabinets

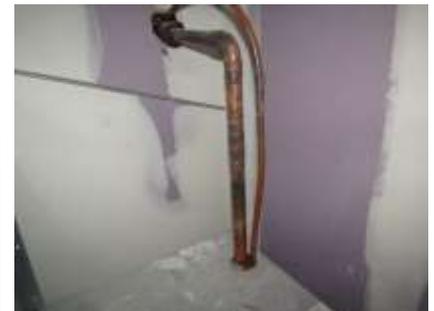
Second level suction/refrigerant line not insulated and sealed at cabinet

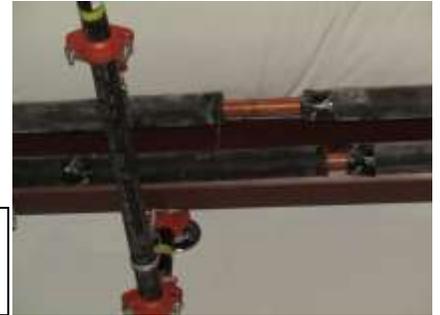
**Missing insulation on refrigerant lines in warehouse**

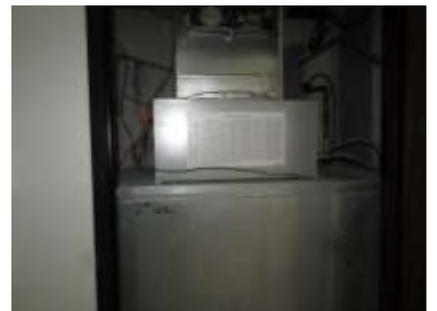
**(D)** Unable to obtain cooling function and operation off of two second level office units therefore suggest immediate examination by reputable HVAC trades to thoroughly examine all eight units, clean coils, flush out drain channels and replace filters to obtain maximum temperature difference efficiency.

**Second level office units not cooling**

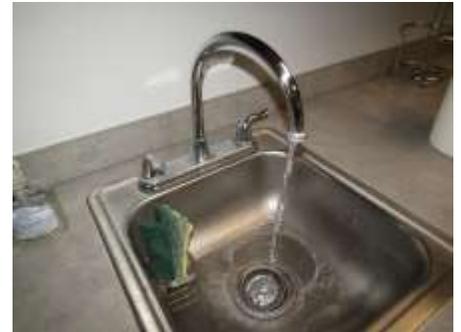
KITCHEN FIXTURE: **(D)** Weak water pressure at fixture with missing optional aerator.

**Weak water pressure for kitchen fixture**
