**ABLE INSPECTIONS**  
*Inspecting Commercial Buildings Since 1976*  
**713 465-0000**

**PROPERTY INSPECTED:**  
Houston, TX

## **COMMERCIAL BUILDING DESCRIPTION w/FRONT OFFICES and REAR WAREHOUSES w/TWO BAY DOORS**

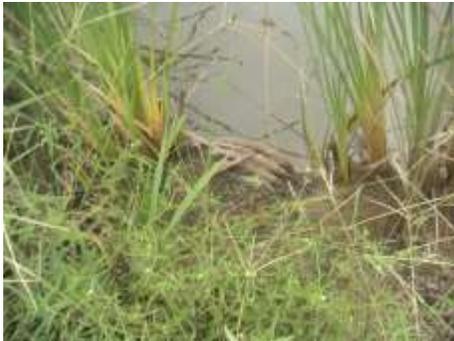
**One of two parking lot drains into rear pond**

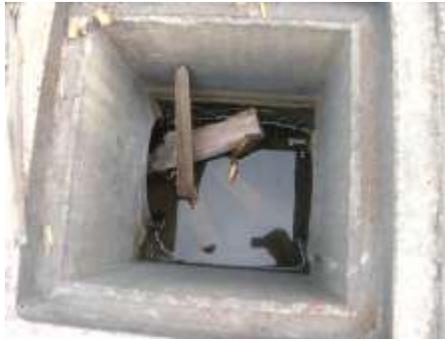
Missing grate cover on rear south parking lot drain basin.

**Missing grate cover on rear south parking lot drain basin**

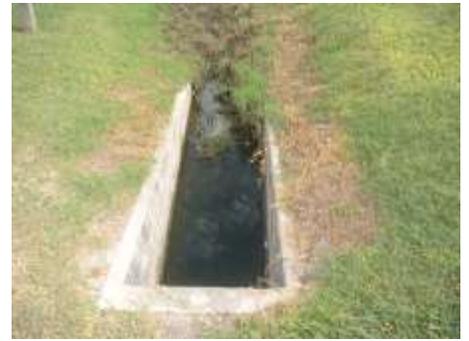
**Clogged front culvert**

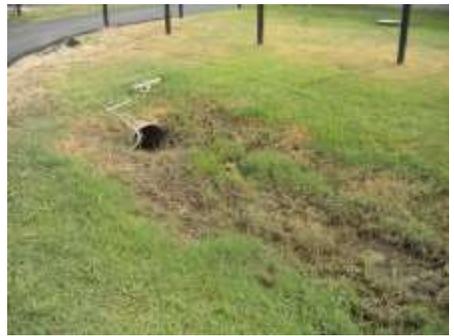
**Poor excavation of front culvert**

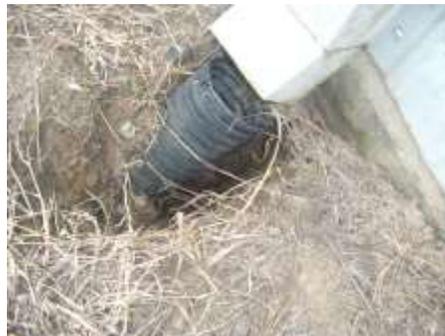
Substandard installation of black plastic drain connections at rain gutters located at north side of 6704 building from missing transitions in addition to some erosion that resulted from poor connections of gutters and available drain pipes. Significant accumulation of water in front west drain culvert system parallel to the street in need of examination for "excavation" to move this accumulation of water and minimize harboring of mosquitoes and other pests, etc.

**Poor drain connection off gutters and erosion**

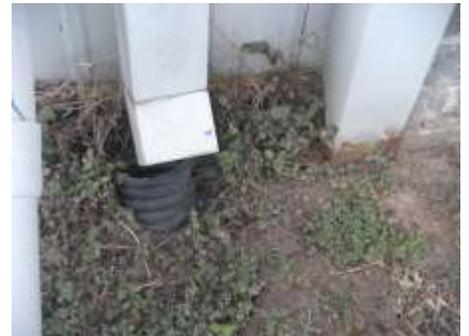
**Poor connection of gutter and black drain pipes**

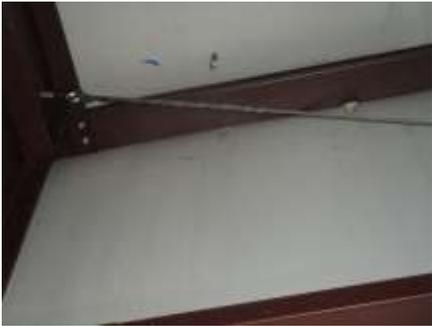
**Water leakage at rear southeast warehouse**

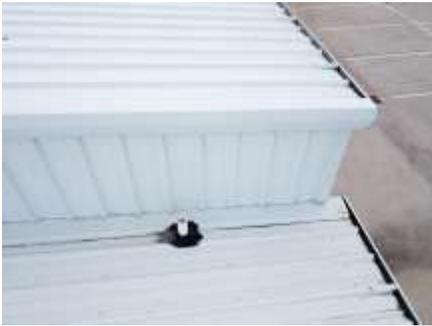
**Two tar sealants on PVC drain waste projection**

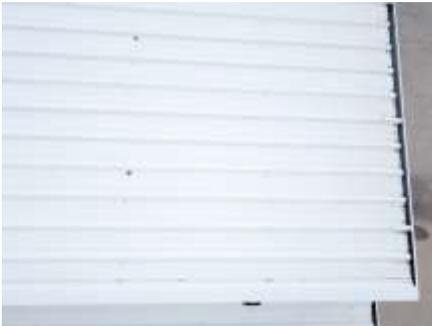
**Tar sealant at screw fasteners**

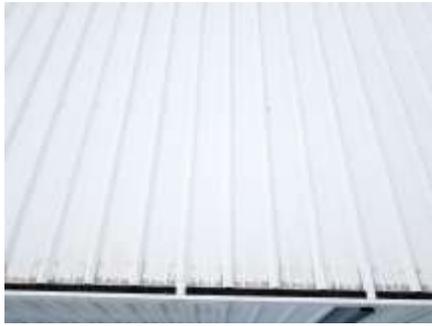
**Clean debris out of gutters**

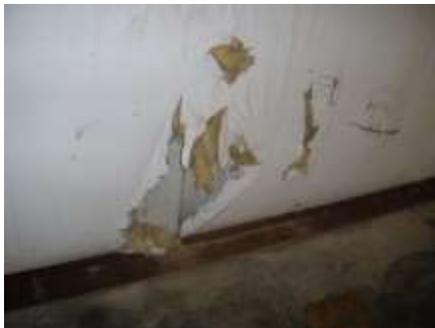
4. Significant stains and discoloration in bathroom of rear warehouse from substandard fixtures.
5. Random locations of damaged and compromised blanket insulation material on walls in warehouse areas.

**Damaged warehouse insulation**

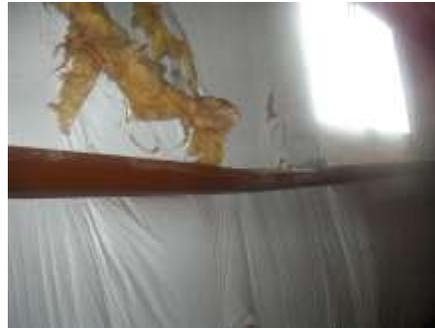
6. Bent and damaged horizontal channel iron at south wall of rear warehouse.
7. Rust located at base of steel beams and fasteners especially at pedestrian and bay doors – activity of water located at these doors during rainfall.

**Damaged metal rail inside rear warehouse**

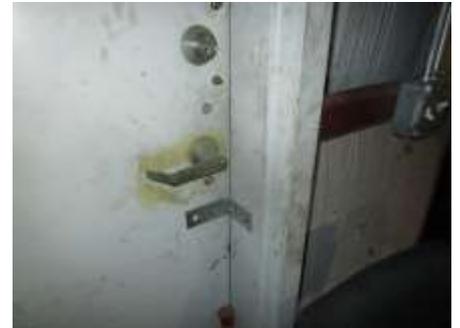
13. Some damaged drywall and wood paneling in warehouse areas.
14. Bolted south side door from warehouse and rear warehouse pedestrian door damaged with worn hardware and cylinder.

**Damaged and bolted side door**

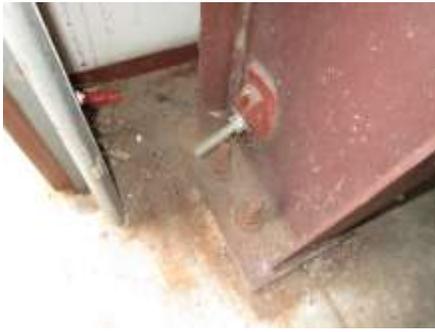
**Rust and water stains**

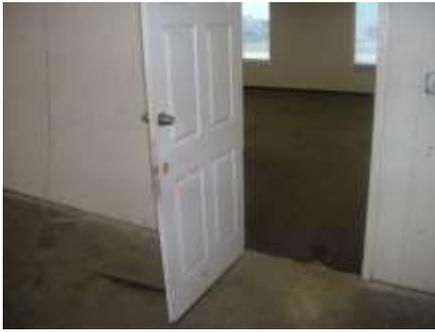
2. Pedestrian doors between office and warehouse are not solid and/or self-closing for fire stop protection.
3. Stains and discoloration located in kitchen and bathroom area at office from substandard fixtures.

**Office/warehouse door not solid and self-closing**

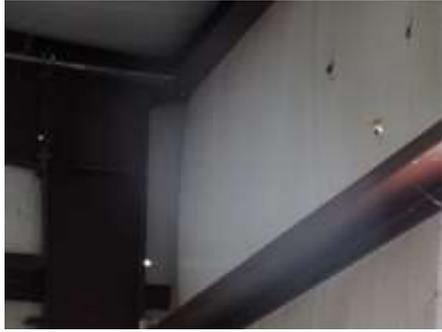
**Holes in southeast siding**

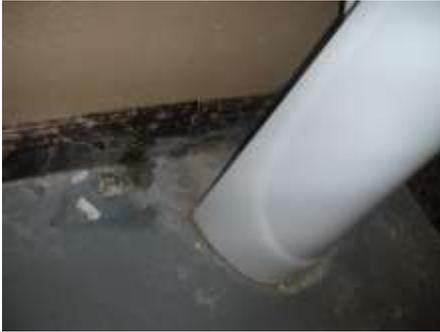
**Stains inside bathroom**

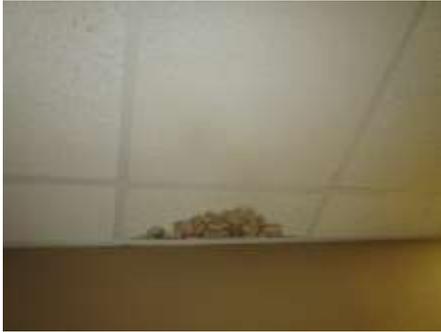
1. Several stained and damaged acoustic tiles located in offices, hallways and kitchen area primarily from HVAC refrigerant line, primary drain line and equipment leakage above these suspended ceilings including the possibility of some roof leaks, however, did not observe activity of water after rainfall during this inspection process.

**Stained ceiling tiles**

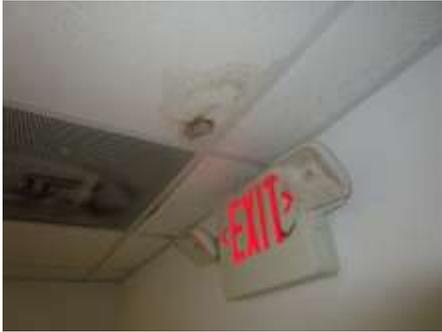
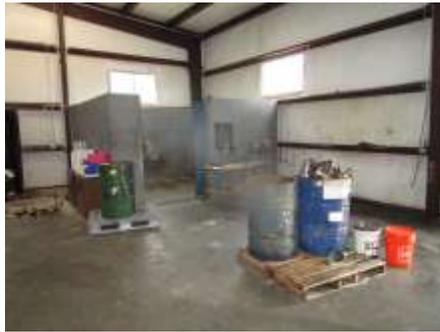
15. Secure and fasten loose door exit signs and have these signs checked for their integrity.
16. Excessive accumulation of stored valves, screws, bolts, flanges, etc. on pallets and shelving at rear warehouse.

**Stored materials in rear warehouse**

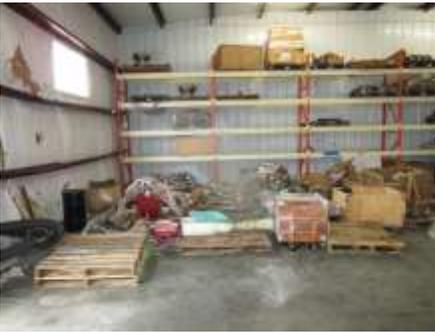
**Stored items in rear warehouse**

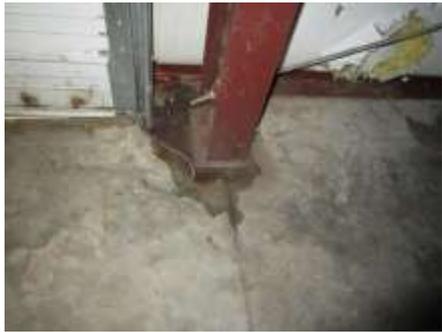
**Water inside bay door during rainfall**

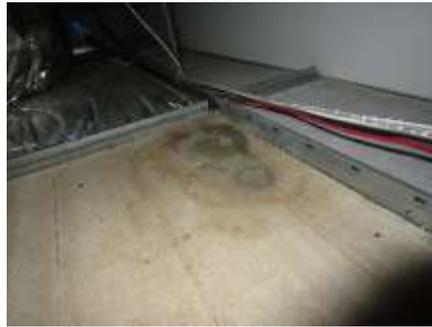
Stained top of ceiling tiles

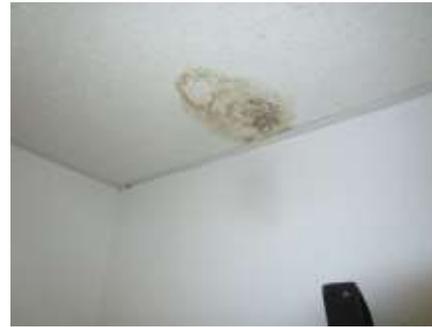
Stained ceiling tile

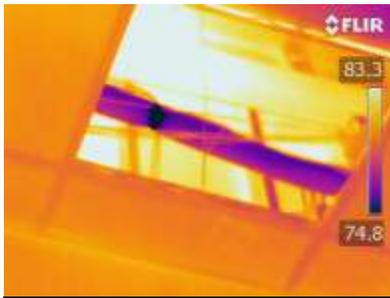
Image of seating HVAC refrigerant line above acoustic tile

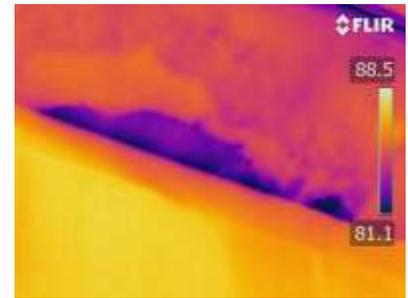
Image of water along north side roof insulation from leakage

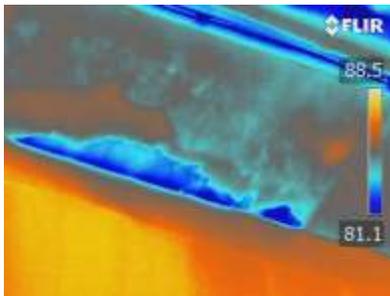
Image of water leakages at north side roof on insulation

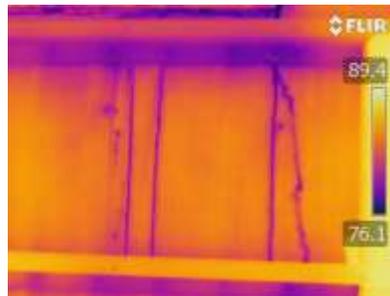
Images of water leakages inside warehouse under windows

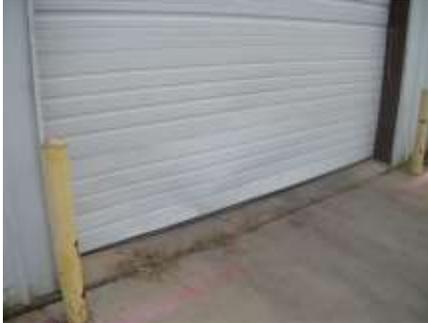
**Damaged rear south bay door panels**

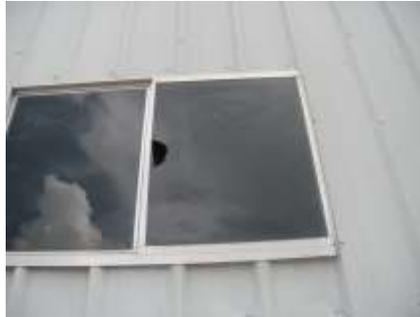
**Broken south window**

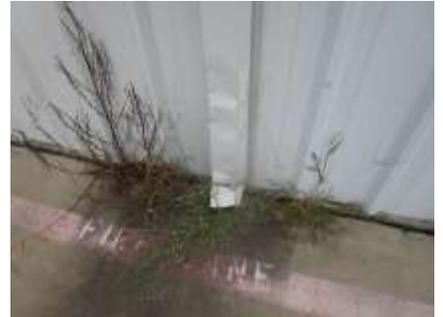
**Damaged south gutter discharge**

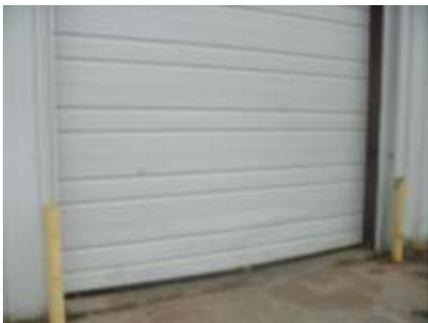
**Damaged south side bay door panels**

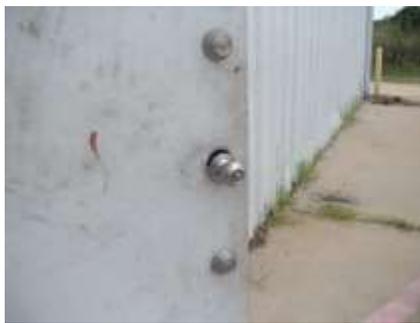
**Damaged south pedestrian door**

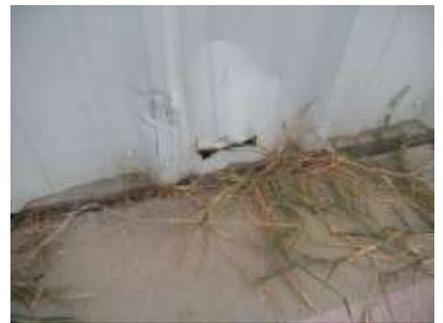
**Damaged siding**

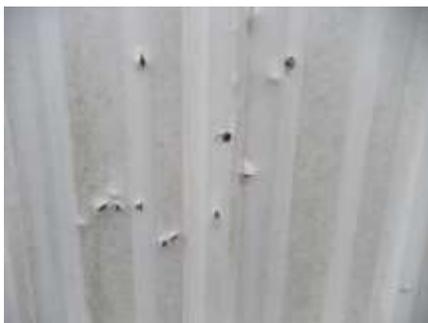
**Holes in north siding**

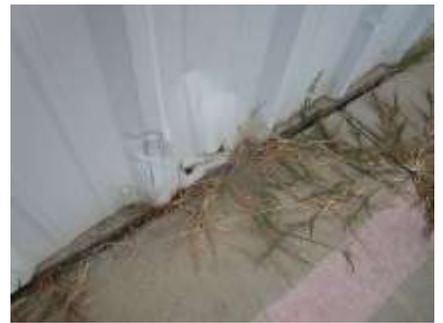
**Damaged south siding**

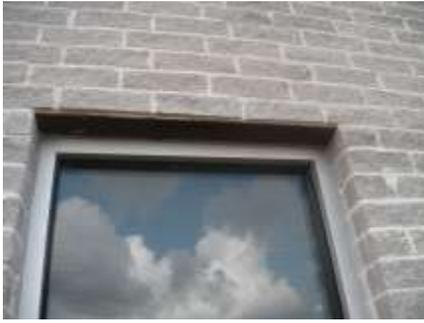
13. Small distress cracks at top and bottom of south side office window.
14. Rust is located at the metal lintels above windows/doors and is in need of immediate repair to reduce distress cracks and potential water intrusion. Weep holes should be provided in the facing, at the level of these lintels to permit the escape of any accumulated moisture, as is recommended by The Brick Institute of America.

**Rusted metal lintels**

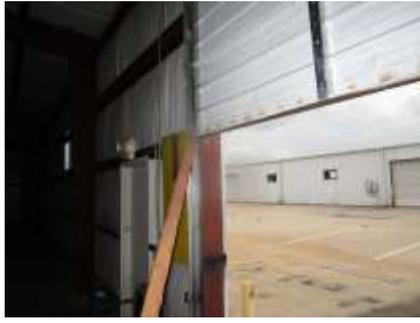
**One large door not staying open**

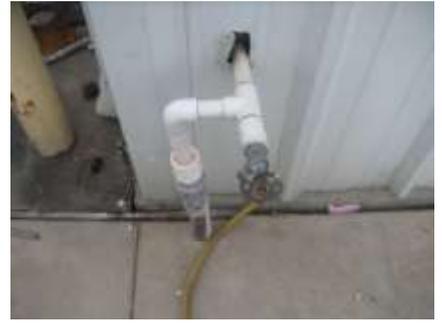
**Insulate water supply and seal voids**

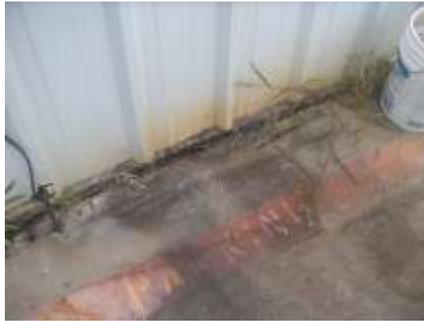
**Stained metal panels from gutter leaks**

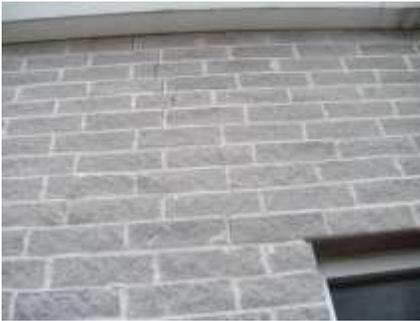
**South brick wall crack**

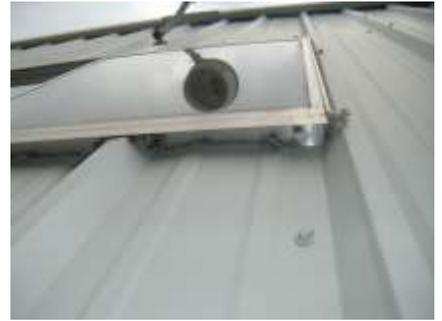
**Seal voids at all windows in warehouse**

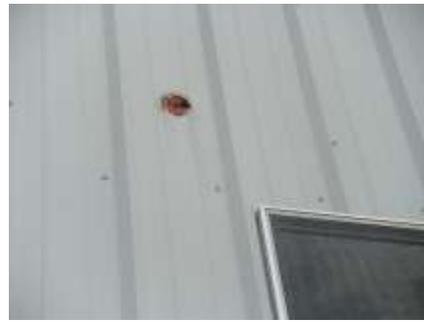
**Missing light for junction box on south wall**

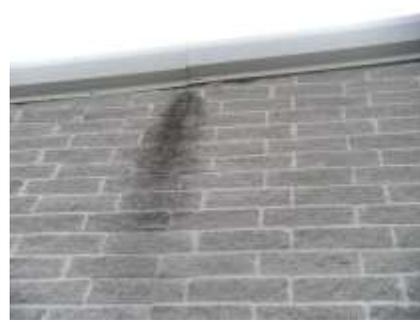
**Stained front brick**

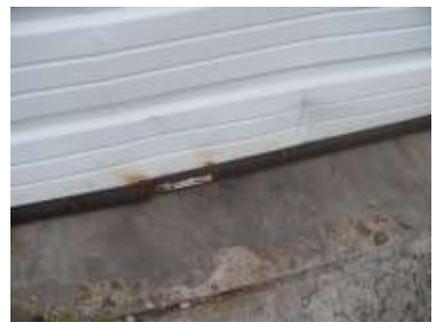
**Rusted and damaged bay door panel**

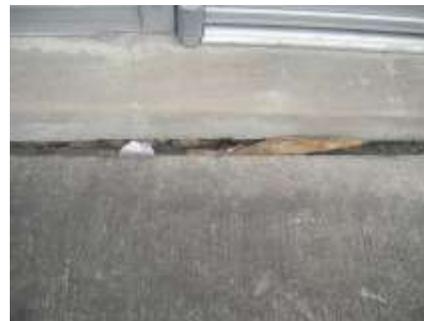
**Damaged wood expansion joints**

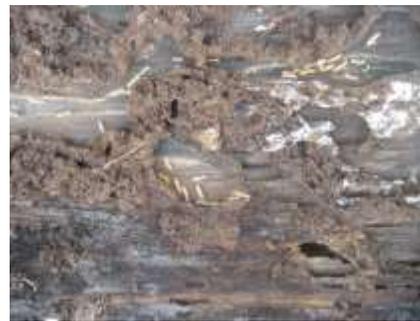
**Active subterranean termites in scrap wood**

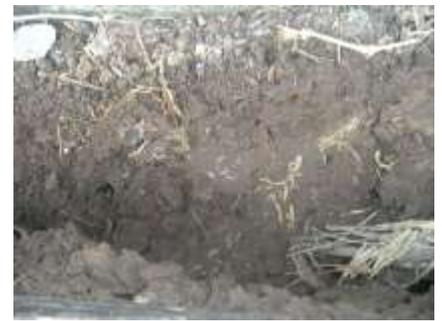
**Active subterranean termites at north side**

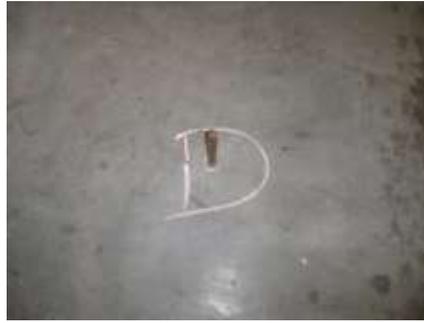
**Exposed anchor in warehouse concrete**

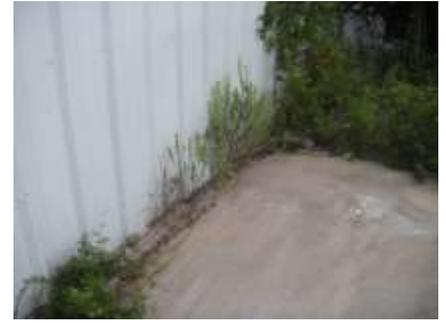
**Excess vegetation at rear of building**

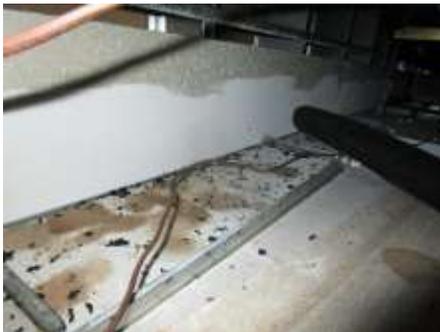
**Stained ceiling tiles and rodent droppings**

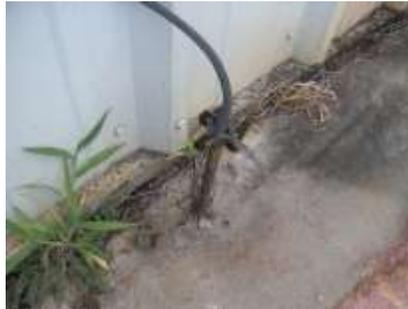
External type is installed on driven earth ground rod. **(D)** Earth ground not driven flush to grade. Using old generation clamps in need of replacement to acorn type.

Old generation clamp on earth rod

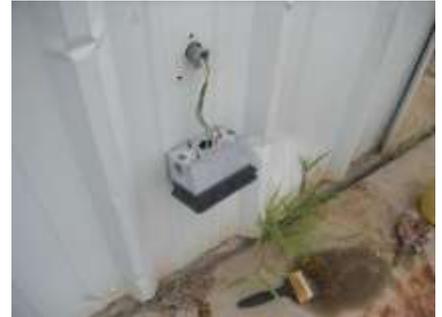
ELECTRIC 120-VOLT OUTLETS: **(D)** Loose outlet at exterior south warehouse with exposed wires. Missing cap on bottom of exterior southwest junction box for GFCI outlet.

**Loose exterior south outlet and junction box**

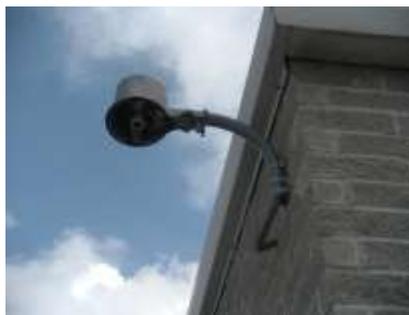
**Broken and non-operative exterior security light**

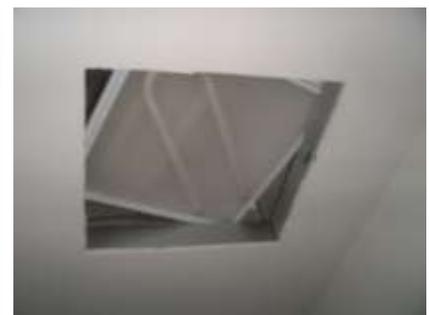
**Loose light fixture at rear bathroom ceiling**

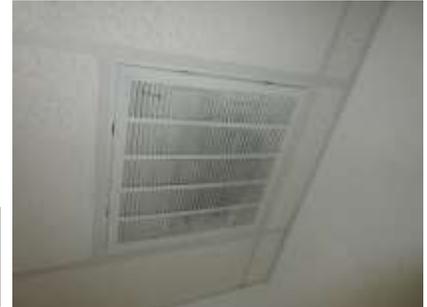
Clean HVAC filter grill and replace filter

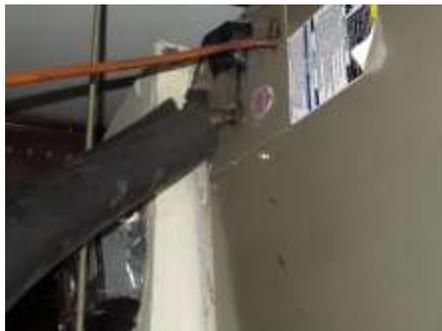
Void at refrigerant line at coil

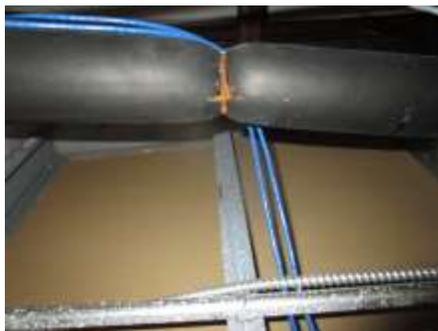
Rusted metal strap and drip leak off insulation on refrigerant line

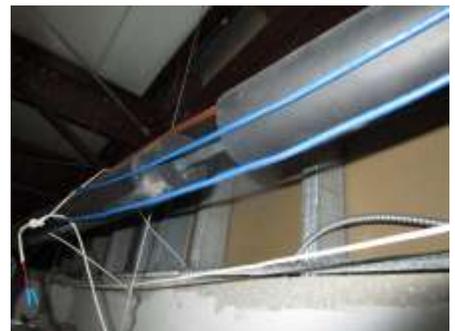
Gap and drip leakage off HVAC refrigerant line

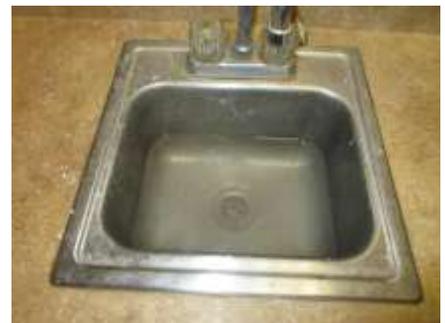
Slow drain in kitchen

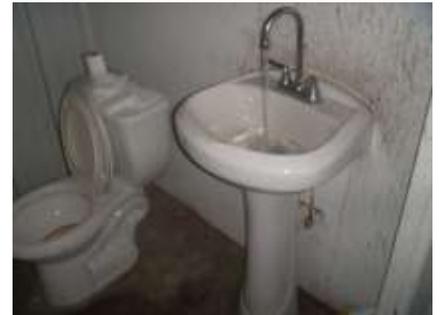
- (D) Worn fixture and basin.

Poor plumbing fixtures at rear warehouse

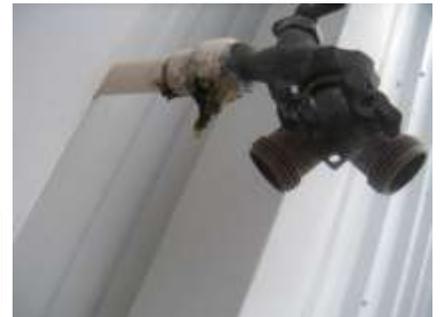
- (D) Leak off south side hose bibb.

Leak off south side hose bibb

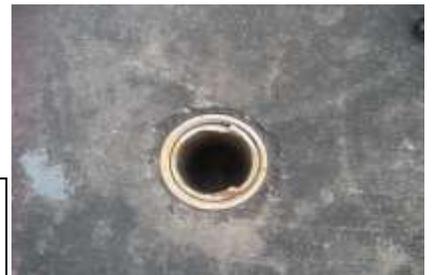
Located at front and southwest of office building and warehouse. (D) Broken cap at south side parking lot area.

Broken cap on south sanitary drain

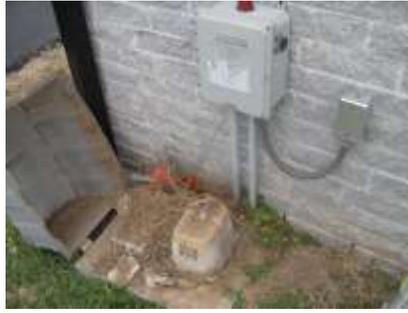
Clearstream Aerobic septic system installation. (D) Excessive dirt, ants, etc. on equipment and pumps at front of office building. Cap missing on suspect tank at rear northeast of building.

Dirt and ants at septic system equipment

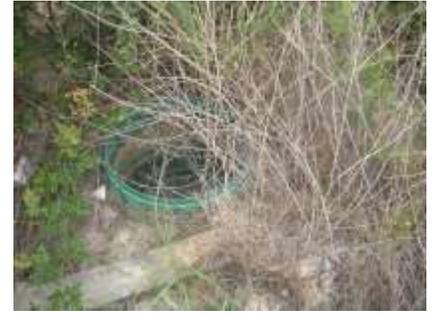
Open cover on suspect sanitary drain
