INFRARED and MOISTURE DIAGNOSTIC REPORT

ABLE INSPECTION CO and INFRARED SERVICES

CLIENT: Joe Sample

PROPERTY SURVEYED: Houston Texas

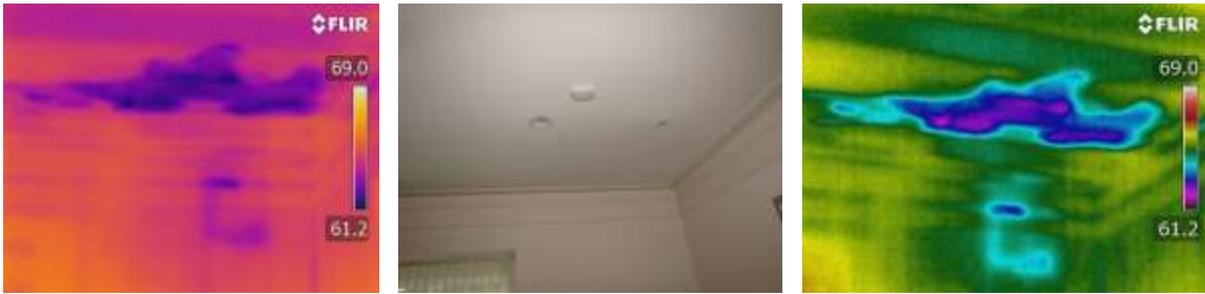
- **Stained ceiling in dining room with master bath shower above**
- **Wet ceiling in dining room corresponding to master shower system above**
- **Stained ceiling in 2nd level boys bedroom ceiling/wall with minimal thermal anomalies (drying out from previous HVAC drain leak)**
- **No anomalies above Master bedroom window system**

Water image on ceiling of dining room with master bath shower above

- **Remove ceiling in dining room to examine for water leakage from master shower above**
- **Improve master shower door gasket system**

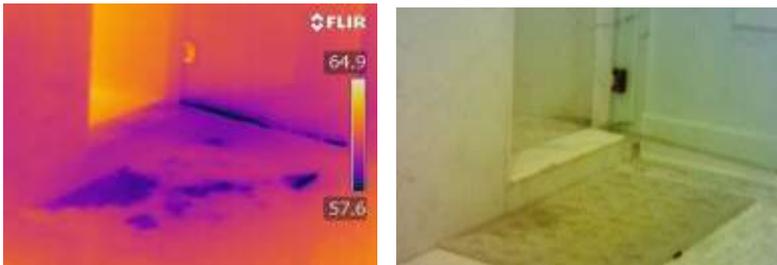
Wet images at base outside of master shower

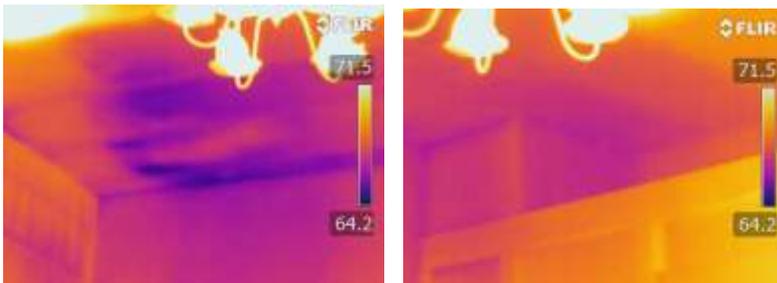
Image of previous water on left side ceiling in boys bedroom...dry on right image

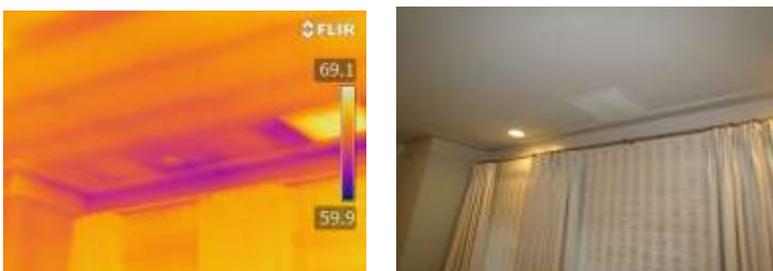
No water anomalies above master bedroom window system

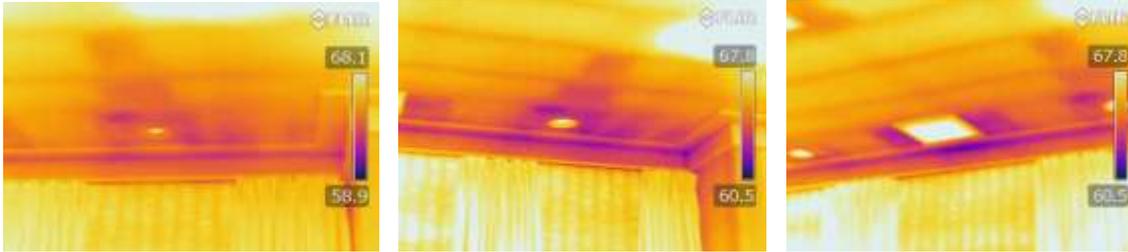
No anomalies above master bedroom window wall and ceiling (cool images from cold exterior temperatures)
