INSPECTION ITEM

II. ELECTRICAL SYSTEMS

A. Service Entrance and Panels

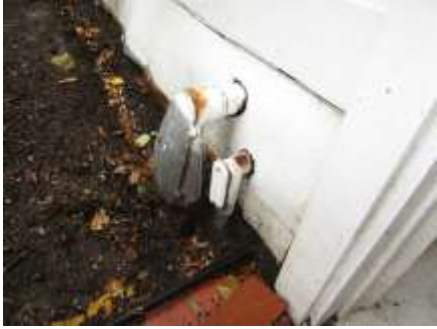
Aerial 3 wire 3/0 copper service into 225 amp Square D main principle disconnect located at exterior rear garage. (D) Rust on dead front cover and missing screw. Additional bonding not installed on metal bushing to the service meter. Rust on LB and conduit at grade level at front exterior garage and unknown integrity of this conduit and feed wiring between house and garage.

Rusted LB and conduit at garage to house

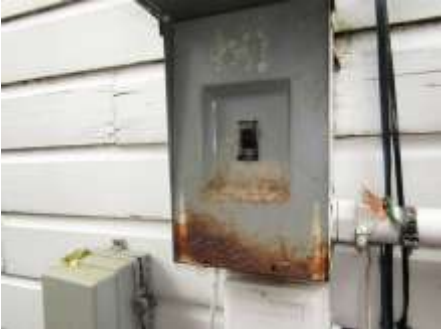
Rusted dead front and missing screw at main panel

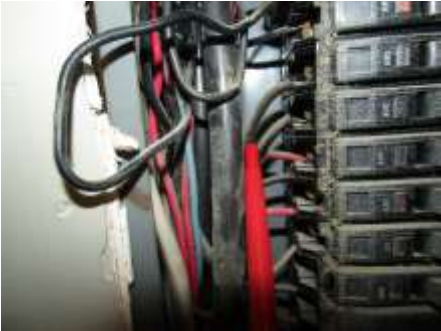
2/0 copper service into 200 amp Square D copper panel box located inside southwest wall with additional 150 amp breaker disconnect. (D) Two knob and tube circuits utilized on breakers.

Two knob and tube wires on breakers in house

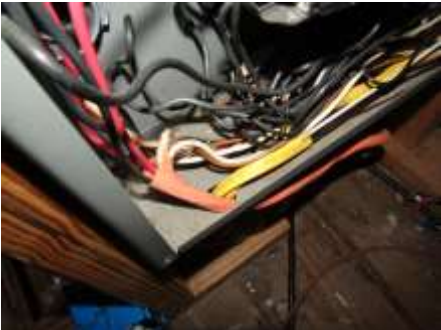
150 amp Square D copper panel box located in third level attic. (D) The protective sleeve or bushing fitting is missing inside this panel box at bottom concentric knockout. This condition will compromise the sheathing for the romex wire and has the potential to cut into this wire and cause an electrical failure.

Missing connector of cable wire on panel in attic

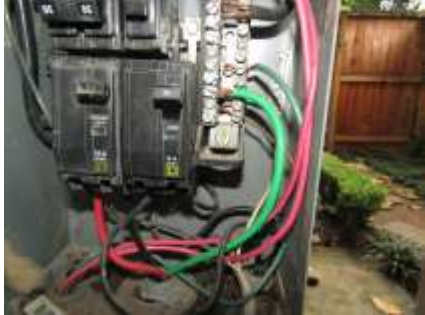
(D) No external earth ground rod and wire installed for this electrical panel box system (possibly using internal grounding, which is not accessible/visible to us at time of inspection).

No ground wire on exterior east panel

Additional grounding electrodes are now required as today's building codes and suggest consulting with electrician contractor of your choice for this additional installation.

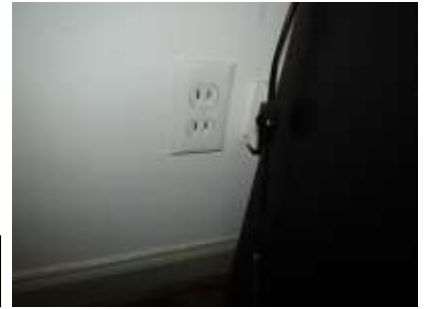
Two and three prong type. **(D)** A small number of electrical outlets are located in random first and second level original rooms and may be inadequate for necessary appliances/lights, etc. (Consult with a Master Electrician for their advice). Receptacle outlets should be spaced no more than six-feet apart along an unbroken space of wall so that appliances with six-foot cords can reach an outlet. If a door, bookcase, window and/or a fireplace breaks an open space of wall then a receptacle outlet must be installed when there is two feet or more of wall space – the is a NEC code requirement. Several open grounds are located on three-prong outlets inside this residence and can be reviewed for grounding methods by an electrician of your choice. Missing cover plate on outlet in southeast room, in attic and garage. Optional outlets not installed near exterior doors and front pedestrian door, however, are located at exterior areas.

Two prong outlet in foyer

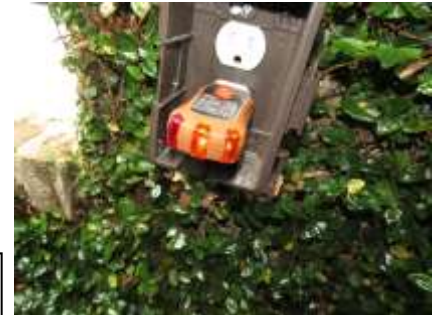
GFCI CIRCUITS: Located in kitchen, kitchen island, bathrooms and quarters bathroom. **(D)** All exterior outlets not protected and also inside of garage. Unable to locate GFCI for the master Hydrotherapy tub motor (consult with seller for this location). All kitchen outlets not protected alongside and rear countertops.

Not GFCI at exterior outlets

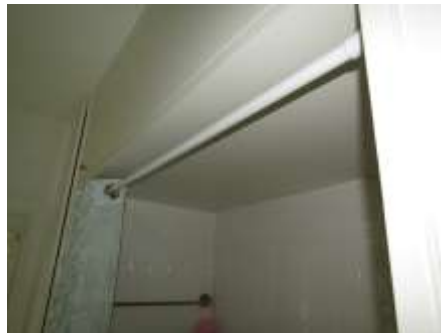
LIGHTS FIXTURES: **(D)** A light is not installed on the ceiling of the second level northwest bathroom shower/tub to illuminate this enclosure. One light not operative at upper southwest shower and one of two at front exterior ceiling. No globe/lens protection exists on incandescent lights in closets, garage and attic, which will prevent electrical spark if the light is damaged (pull cord type lights). Several burnt and non-functioning bulbs on fixtures at kitchen cabinets/countertops.

No light in upper north tub

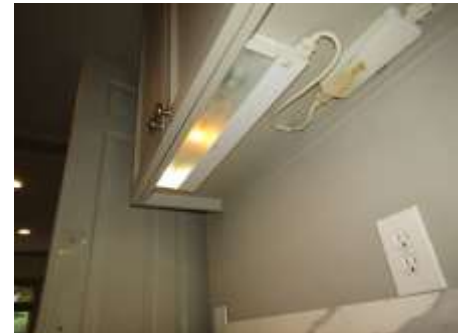
Several under cabinet lights burnt out

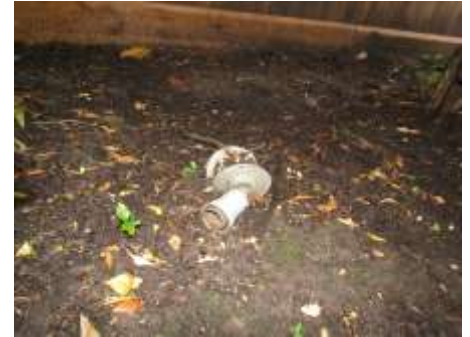
(D) Rusted 1/2" and 1" conduit at east side exterior and unknown integrity of any and all underground electric conduit installation. Photo electric eye functions northwest security light and its function and integrity is unknown to us. Broken and unused landscape lights at rear southeast landscaping (all landscape, tree lights and other security lights considered "as is").

Broken landscape lights

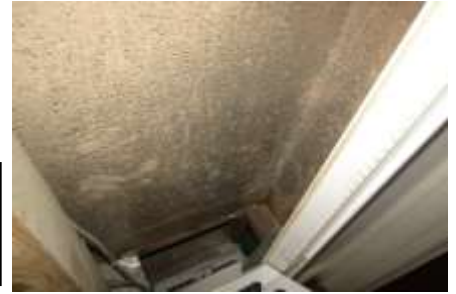
(D) Clean interior chase used for first level system as viewed from second level return air grill. Consult with HVAC contractor to examine installation of this return air chase and size for this unit due to narrow wall opening. Replace filter grills at all locations.

Clean dust for first level return chase in second level hallway

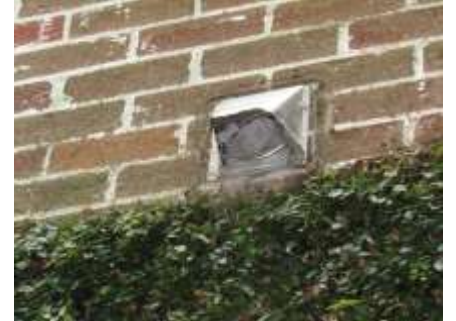
(D) Clean excess lint accumulation out of this vent pipe to the exterior. The exterior dryer vent cover is damaged and the flapper is stuck open with lint accumulation.

Clogged dryer vent

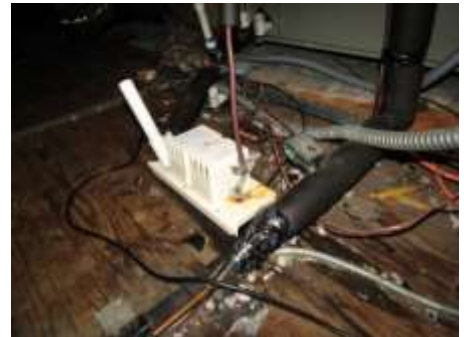
(D) Active leak off of first level condensation pump onto attic deck. The condensate drain line from the air conditioner evaporator coil terminates on the exterior adjacent to the foundation grade beam – east side. This is not a desirable condition and we suggest retaining the service of a reputable HVAC or Plumber contractor to relocate this drain line into the interior plumbing system. Insulate drain line piping off of pumps and thoroughly clean pumps and install water detection devices off of pumps. First level pump not installed into an emergency pan. These drains should also be cleared and flushed with Spring and Summer season operation.

Water leak off first level HVAC drain pump

Consult with HVAC contractor of your choice for the installation of available “union slip disconnect connection” on primary and emergency drains for service and maintenance. In addition, the necessary installation of “water level monitoring device” also on all drain line piping from coil and for both electric pumps for drains.

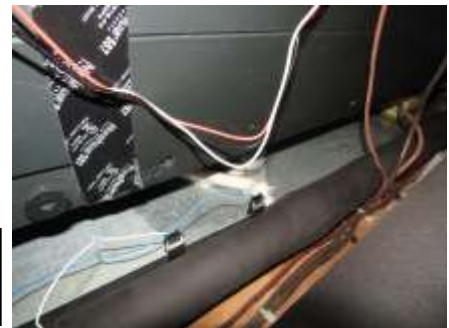
(D) We suggest installing 45 or 90-degree fittings on all horizontal drains extended outside of this residence at northeast area. These 45 or 90-degree fittings will prevent staining of wall material if the drain is activated. Water in second/third level master pan with suspect leakage onto master bedroom ceiling.

Water in second/third level HVAC pan

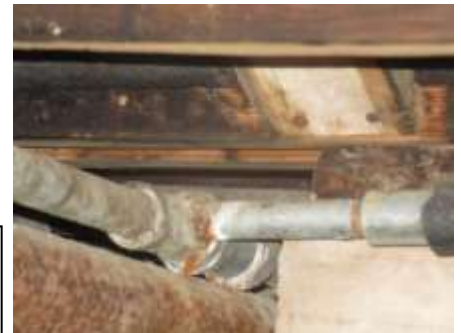
SUPPLY PIPING: Original galvanized steel with some copper piping replacement. **(D)** Evidence of rust and corrosion on galvanized steel piping in crawl space areas and exterior east side of residence and off of hose bibb. Evidence of rust and corrosion and coupling repairs on piping in garage. Unknown integrity of any underground piping installed between house and garage.

Rust on steel water piping under house

Obtain all detailed information from seller of any repairs and/or replacement made with galvanized steel piping since this piping historically does rust, corrode, leak and restrict water pressure supply.

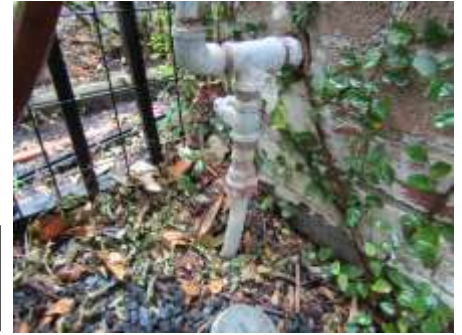
MAIN WATER SHUT-OFF: Located at northwest area of residence with 3/4" copper into galvanized steel piping. **(D)** Complete insulation is missing on water supply piping and stop valve for energy conservation.

Main water supply with no insulation

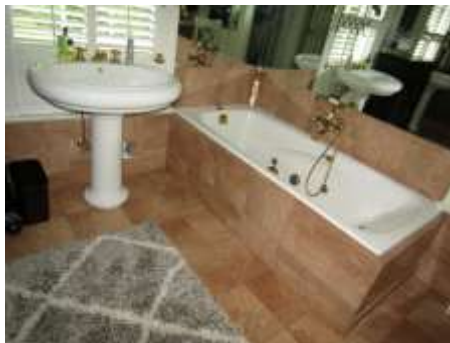
- d) Hydrotherapy Tub **(D)** Without visible/accessible GFCI circuit protection. Weak and clogged hand-held sprayer operation. Unable to obtain operation of motor pump. Leak on tub diverter stem during operation.

Master tub not operative

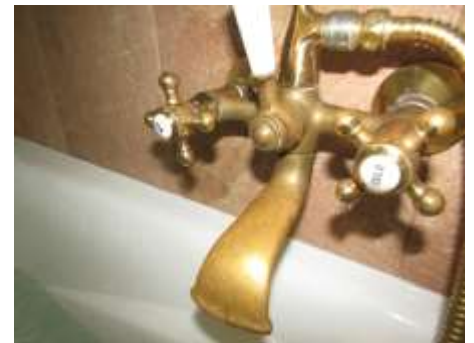
Leak on master tub diverter and clogged hand-held

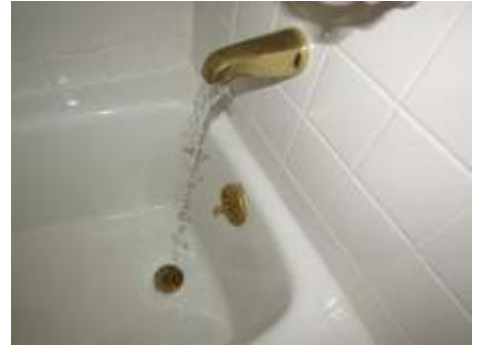
- (D) Weak water pressure out of fixture.
- (D) Weak hot water supply pressure. Unable to obtain adequate pressure off of tub to operate showerhead from diverter.

Weak hot water in tub

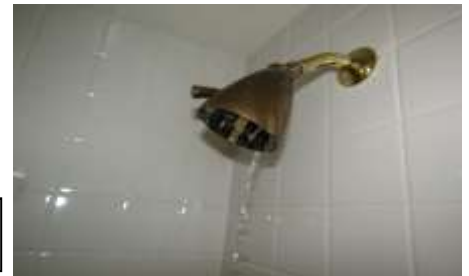
- (D) Adjust the pop up and linkage controls to hold water in basin.
- OP, however, no door gaskets on décor shower door. Weak water pressure at shower.

Weak water pressure at shower

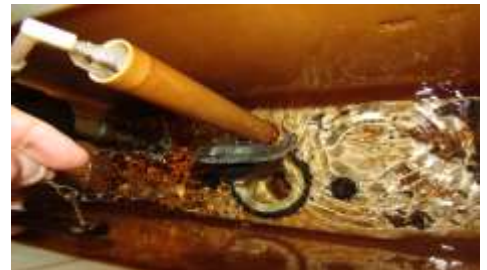
- (D) The ball cock valve leaks and the flapper ball is worn and leaks. Old stop valve noted.

Worn toilet parts

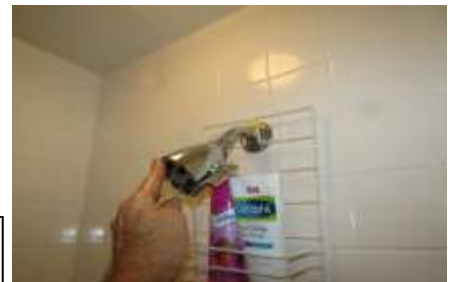
- OP
- (D) Loose shower arm out of wall.

Loose third level shower arm

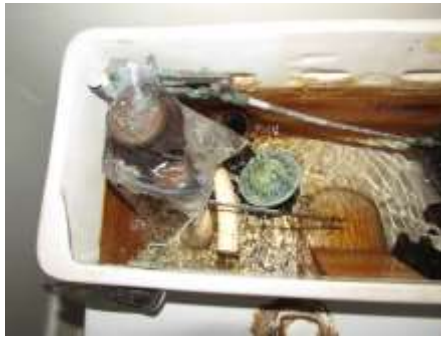
(D) The ball cock valve leaks and the flapper ball is worn and leaks (plastic bag over ball cock valve). Worn toilet seat. _Water leakage under toilet.

Worn parts for toilet

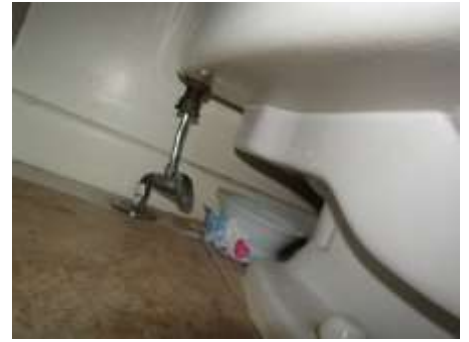
Water leakage under toilet

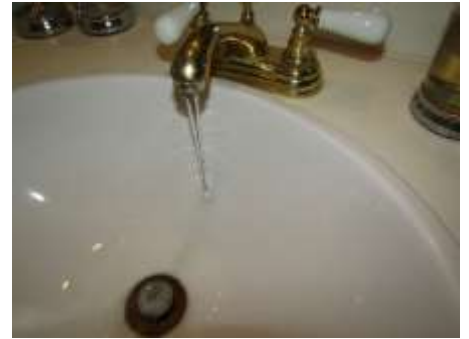
(D) The aerator on this fixture spout is clogged and is restricting positive flow (remove and clean out debris). Weak pressure at lavatory.

Weak pressure at lavatory

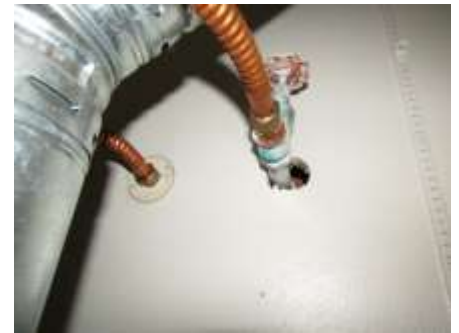
2009 Reliant 40-gallon gas tank located in quarters. **(D)** Significant rust and corrosion at brass cold stop valve and fittings. Unit not operative and turned on during inspection for testing of hot water. Rust on top of cabinet from water drip leak off of stop valve.

Corrosion on quarters water heater stop and fittings

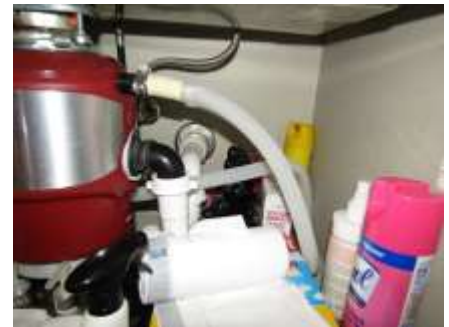
A. DISHWASHER: Bosch type. **(D)** Secure and raise drain hose above disposal inlet.

Secure and raise dishwasher drain

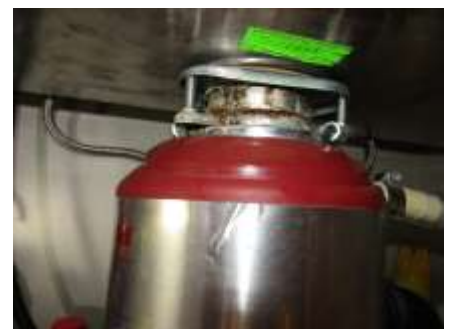
B. FOOD WASTE DISPOSER: Kitchen Aid 3/4 H.P. type. **(D)** Rust and corrosion on collar attachment to the sink from previous leak with some rust and staining on housing from leak that had occurred at one time that could not be duplicated during this inspection.

Corrosion at disposal connection

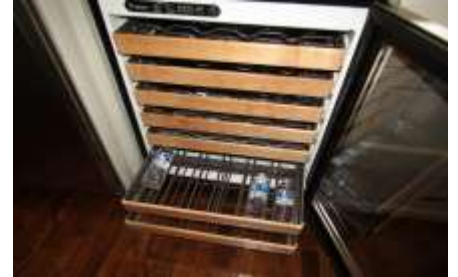
GE type located in kitchen. (D) Unable to obtain operation and cooling of this unit – consult with seller for more detailed information.

Wine cooler not cooling

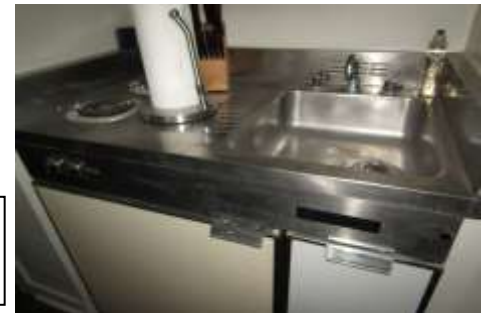
Acme type located in quarters. (D) One of two burners not operative. Refrigerator unit not operative. This old generation kitchenette unit is in last stage of useful life.

Old generation kitchenette in quarters

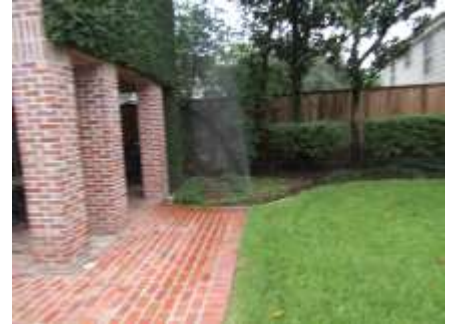
And/or a licensed irrigator utilizing the proper detection equipment – all eight not located. Adjust the shrub sprinkler heads that are located within close proximity of the exterior building materials, such as at the windows, doors, brick and stucco, and especially at any wood materials to reduce the potential of staining, discoloration and interior/exterior building material damages. Several loose sprinkler heads and some uneven installation in landscaping. One broken sprinkler head at rear southeast yard. Sprinkler irrigation system not installed with common clockwise or counter- clockwise type sequence that can be adjusted by irrigator contractor as necessary.

Broken sprinkler head

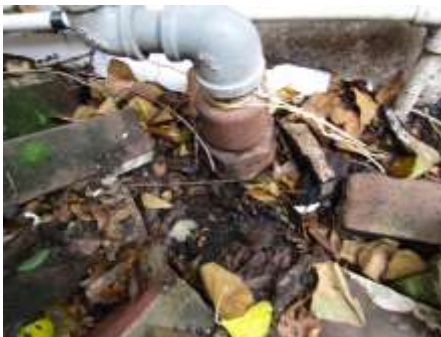
(D) Rust on gas pipe and fittings above and at grade level at rear and side of garage. Unknown integrity of underground gas piping from garage into rear of house. Underground gas supply piping was observed into this building. We recommend immediate pressure testing by a Master Plumber to confirm its integrity. In addition, it is unknown to us on the type and condition of protective wrapping/material used to protect this pipe from deterioration. Exposed piping at exterior east wall with rusted straps.

Rusted gas pipe at grade

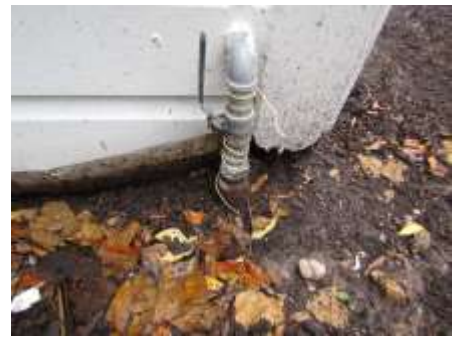
Rusted gas from garage to house
