**ABLE INSPECTION  
COMPANY**  
*Inspecting New Homes  
Since 1976  
713 465-0000*

CLIENT: Joan Sample

DATE – August , 2018

INSPECTOR: Larry Malloy TREC 332

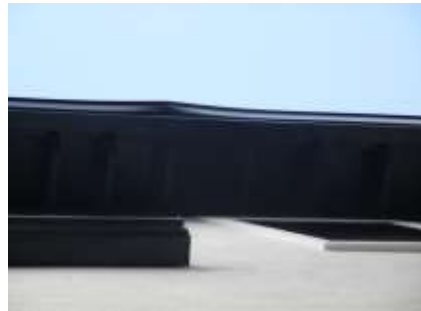
1. Broken hip tile at southwest area of roof.
2. Bent and damaged rain gutter in two locations along east side of upper roof.
3. Clean construction debris, mortar, etc. out of rain gutters to ensure future positive rainwater diversion.

**Damaged east gutter**

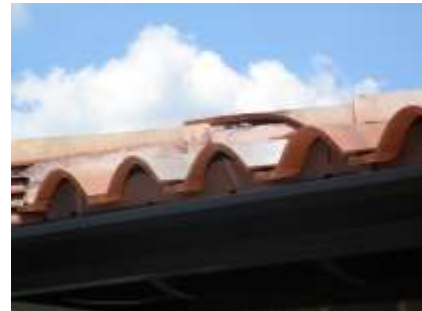
**Broken upper southwest tile**

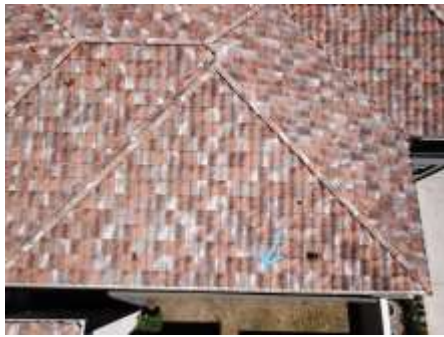
**Hairline cracks at southwest tiles**

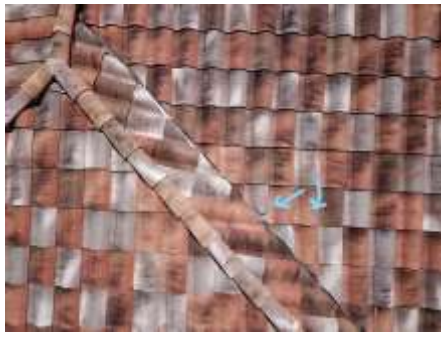
**Broken tiles**

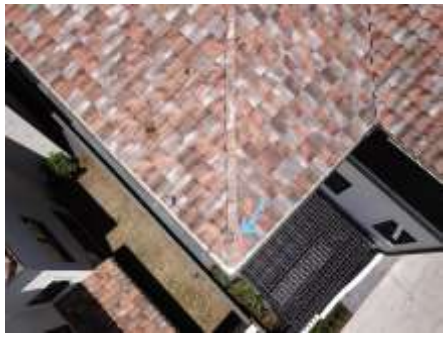
**Broken tile at southwest hip**

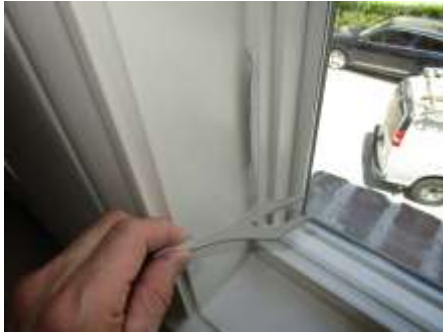
Loose handle for master window

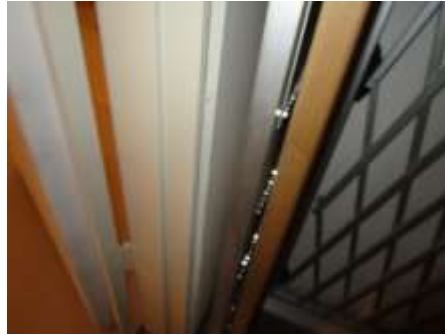
Incomplete trim for wall inside elevator

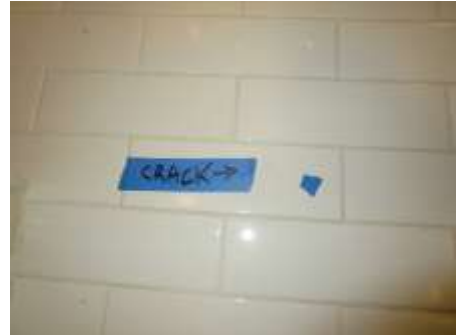
12. Cracked tile in laundry room.

Cracked tile in laundry room

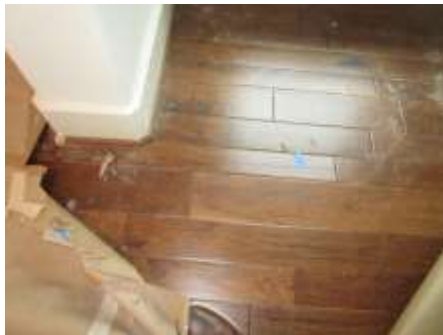
Uplifted wood flooring in third level

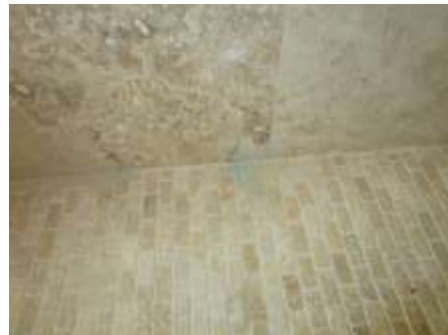
Stained tile in master shower

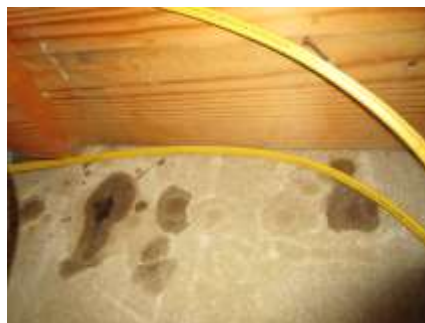
(D) Active condensation leakage exists on third level ceiling off of HVAC duct board plenum and some flex ducts which are sweating and dripping water onto ceiling during inspection process.

Water on ceiling of third level HVAC from condensation leak

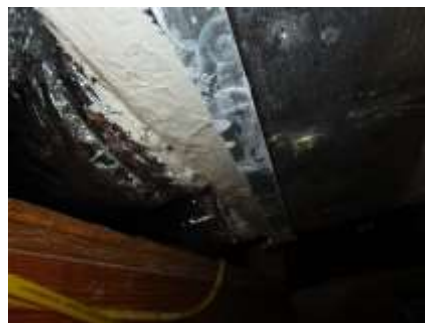
Excess condensation drips off third level HVAC

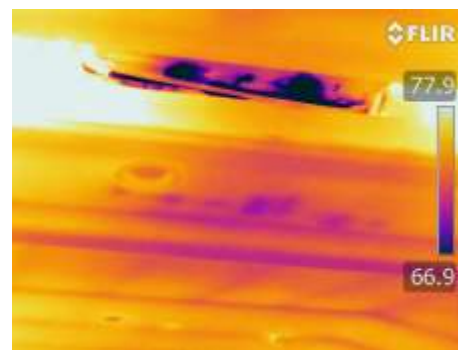
Water leakages on ceiling and 3rd level HVAC equipment

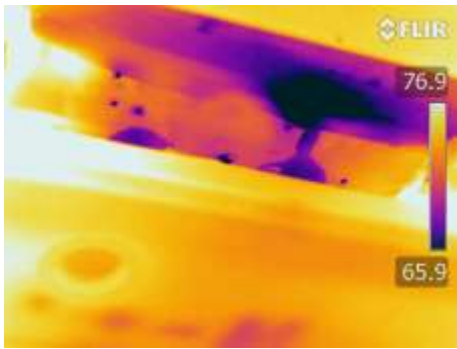
Excess sweating of 3<sup>rd</sup> level HVAC housing and duct board

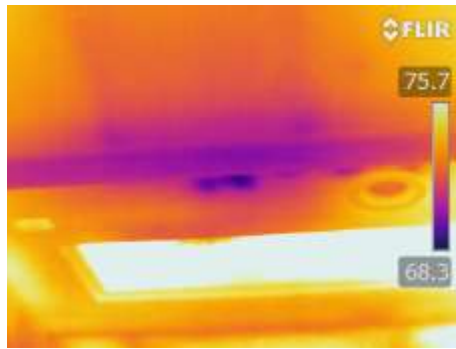
Water images on ceiling of 3<sup>rd</sup> level HVAC

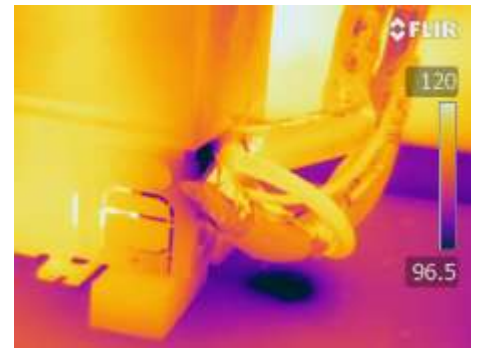
Water off HVAC exterior split system on east side

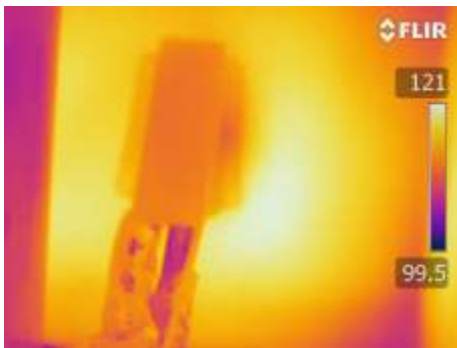
121 degrees at east side enclosure for A/C split systems

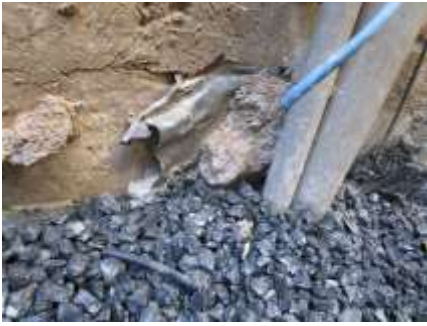
**Remove black plastic off west grade beam**

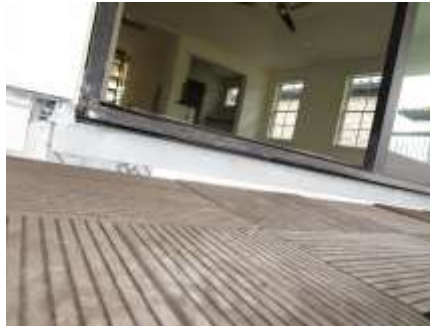
**Missing vertical support under third level balcony threshold**

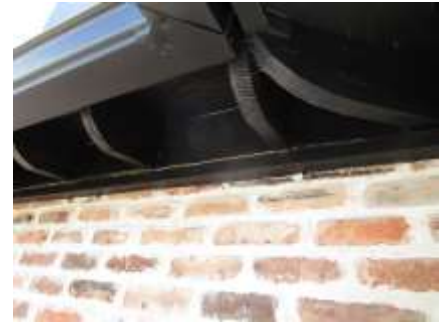
**Loose trim at upper southwest area**

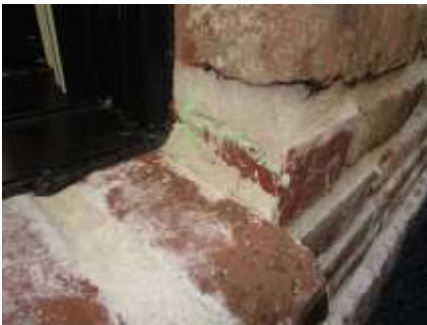
**VOIDS at brick and windows**

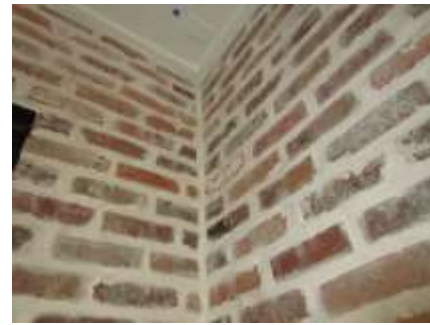
**Vertical corner wall cracks on patio**

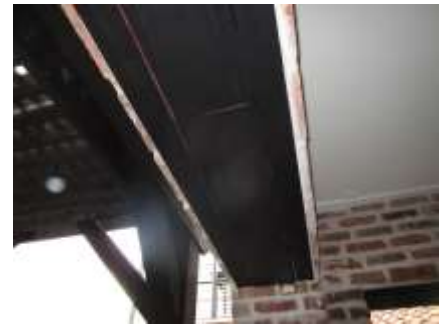
**Uneven wood at rear patio**

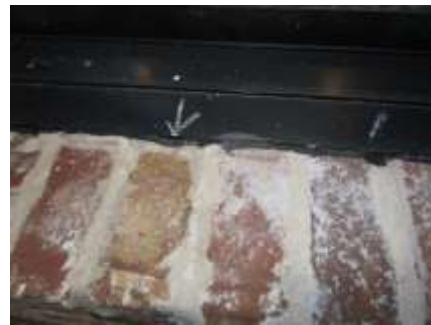
**VOIDS in exterior window and sill caulk**

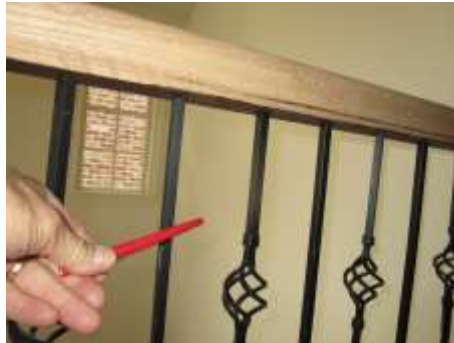
The steps (riser and tread ratio) in the stairs had a normal feeling when walked upon in a normal manner. The handrail was secure. (D) Loose iron balusters in stairs.

Loose iron balusters in stairs

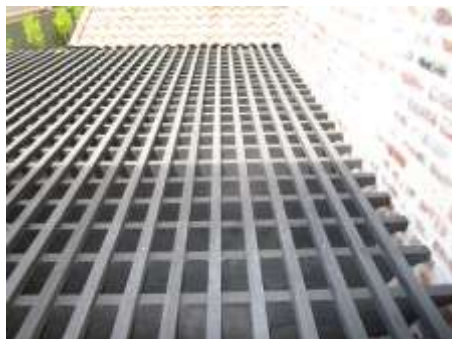
Worn stain on top of patio arbor

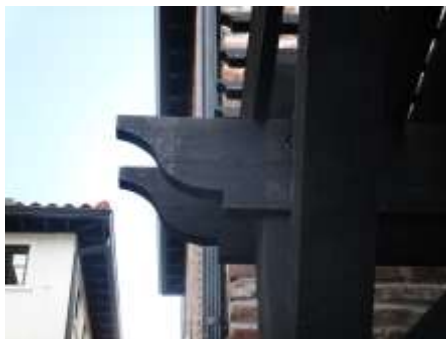
No protection on top of wood

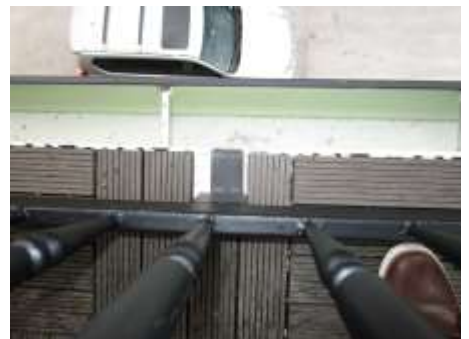
Missing tile paver at third level balcony

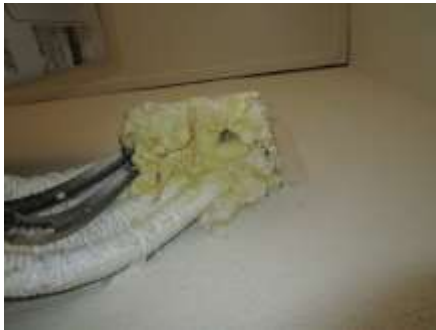
**Poor foam installation at HVAC utilities**

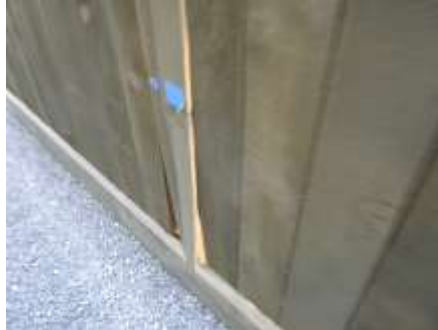
**Loose east side fence pickets**

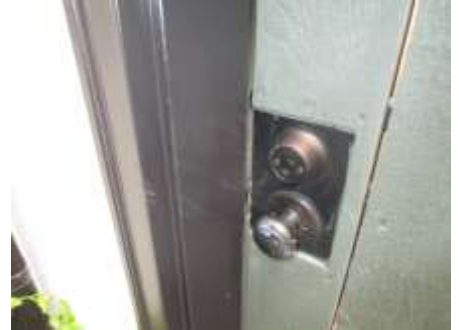
**Adjust rear gate door cylinder**

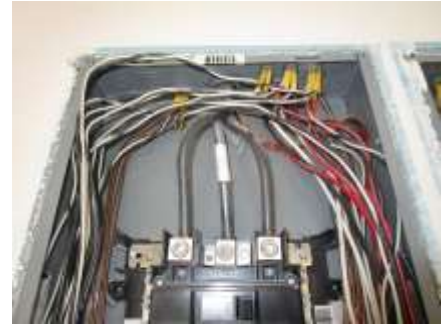
200-amp Square D copper panel box with 125-amp sub panel located in garage with three 20-amp arc fault breaker interrupters and 22 combination breakers on panel box. **(D)** Secure and strap loose cable wires on left panel.

Strap loose wires on panel

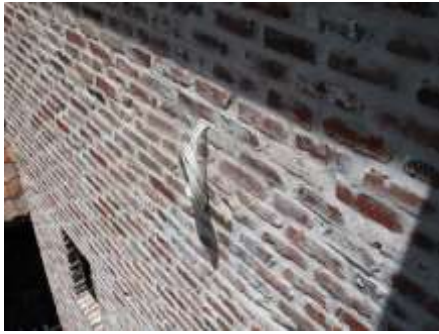
Exposed cable at upper southwest wall

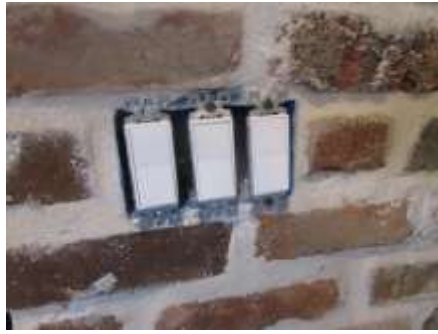
Missing rain and damp proof cover on patio switches

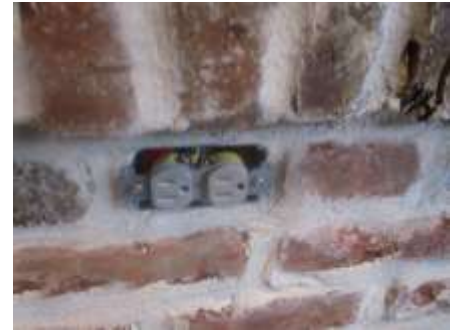
Missing cover on patio outlet

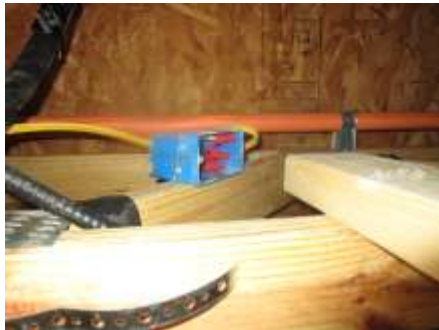
Open junction box in laundry room ceiling

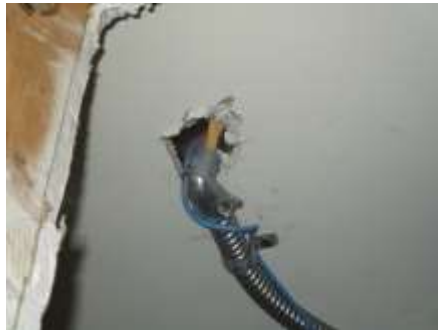
Missing junction box for male electrical in upper elevator

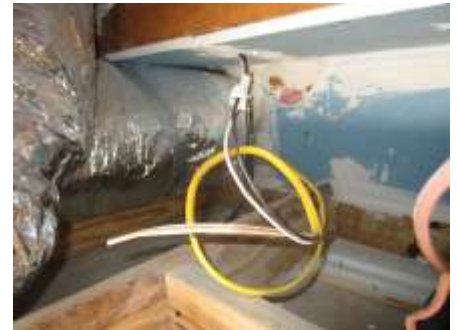
Exposed wires off first level south HVAC

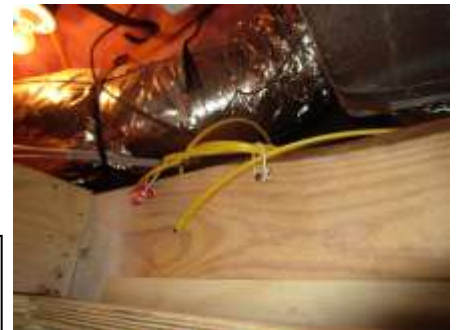
Exposed, loose and unused wires in third level attic

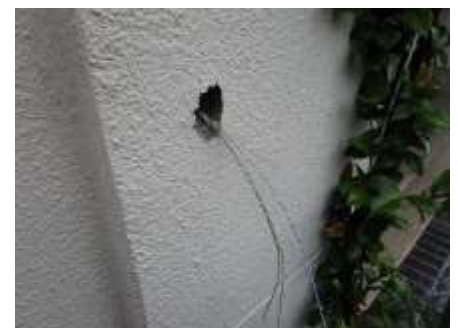
(D) Irregular chime operation. Missing rear south doorbell.

Missing rear south doorbell

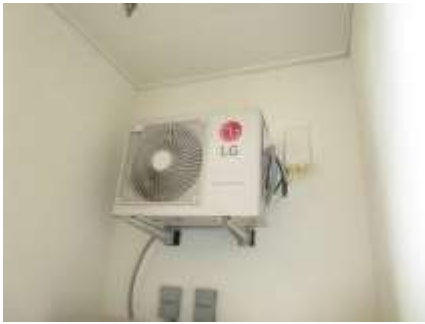
**Vibration in wall from mounted HVAC**

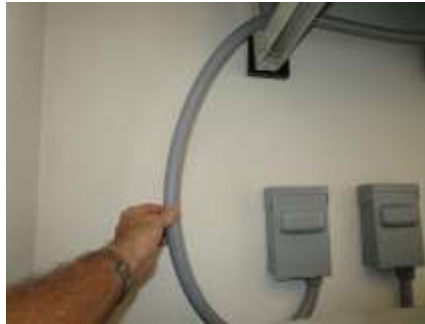
**Loose conduit off HVAC unit**

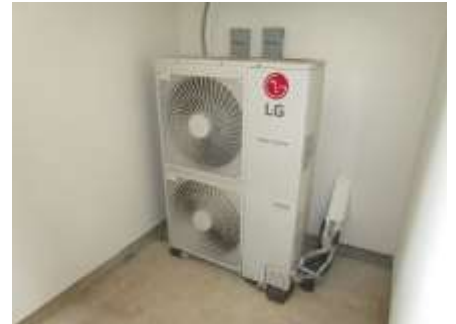
**HVAC units installed in area with limited air**

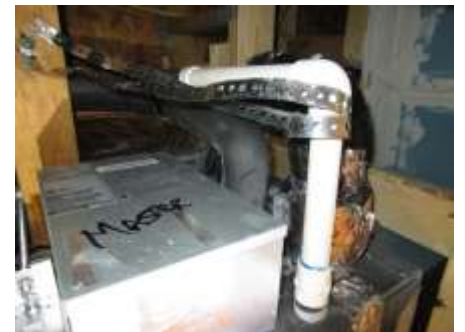
**Vibration off master HVAC air handler**

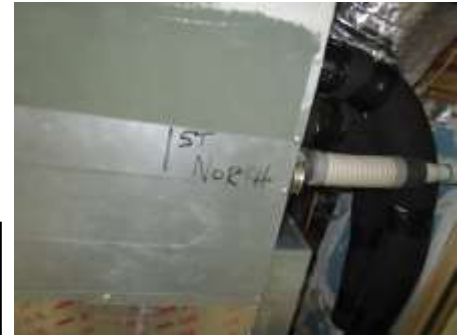
**(D)** Not installed off of all five air handler units above ceilings on first, second and third levels. Riser auxiliary drains installed off of all units with apparent disconnect switch to turn off air handler unit that could not be determined for its integrity during our inspection process.

**No emergency pans under all five HVAC units**

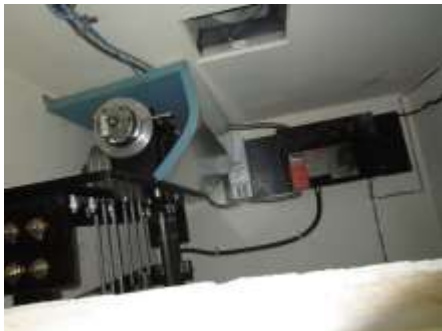
**No air register in elevator chase**

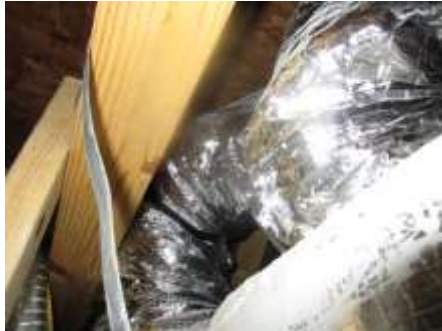
Duct board and foil flexible type. **(D)** 1" air gap not available between several air ducts in attic and off of equipment and above all five air handler units. Excess condensation sweating located, for the most part, off of third level unit in attic onto ceiling that should be further examined by HVAC trade and LG. Missing air register in upper ceiling of elevator shaft. Incomplete insulation on dehumidifier unit drain in attic.

**1" clearance not at ducts**

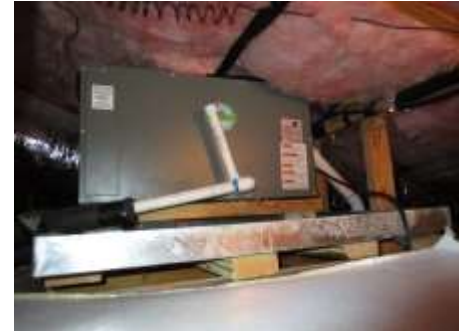
**Incomplete insulation on dehumidified unit drain in attic**

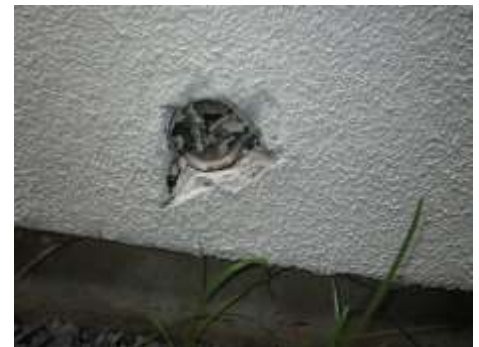
FLOOR DRAIN: One does exist with termination to the exterior. (D) Broken piping and missing elbow fitting at exterior southeast brick wall.

Missing ell for laundry room drain

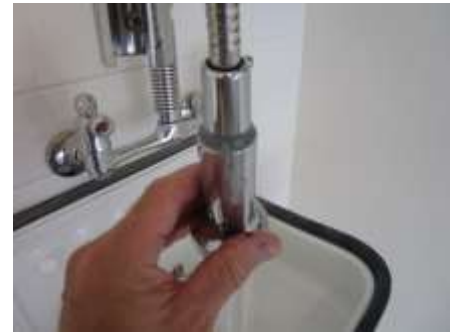
(D) Leak on hand-held sprayer.

Leak off garage hand-held fixture

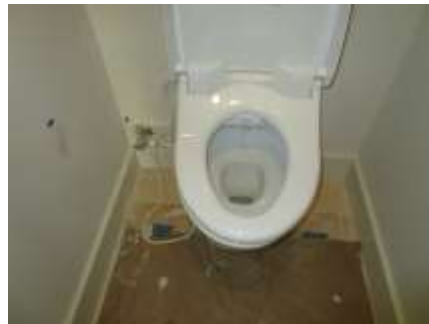
Petite toilet in master bathroom

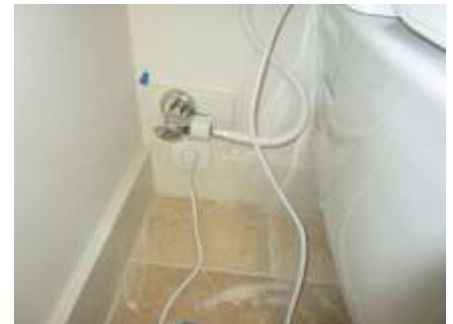
Gebert proprietary toilet and wall controls with Toto Washlet. (D) Loose cord off of this Washlet and void at electrical outlet and piping. Odd shaped bowl for adults installed in this toilet closet that should be examined for upgrading.

Loose cable for master toilet and seal void

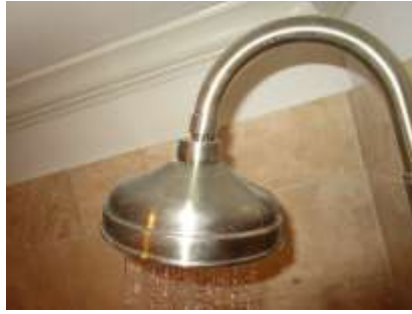
Showerhead leak on second level shower

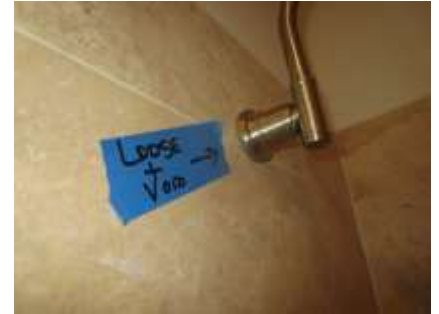
(D) Drip off of fixture after operation. Loose cover with void in second level shower.

Loose cover with void in second level shower

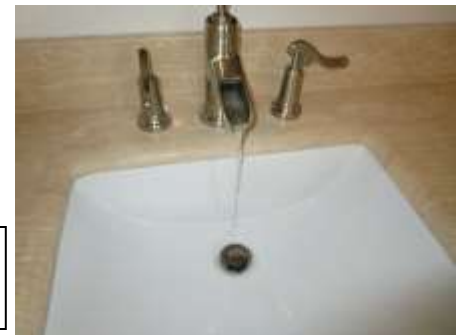
(D) Weak hot water supply pressure at fixture and unable to obtain quality hot water temperatures.

Weak hot water at powder bathroom lavatory

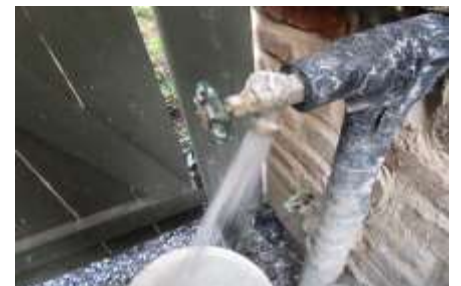
(D) Was not installed on all exterior hose bibbs to prevent future possible cross-connection to domestic drinking water. Some will create noise inside this residence during hose operation.

Missing backflow devices

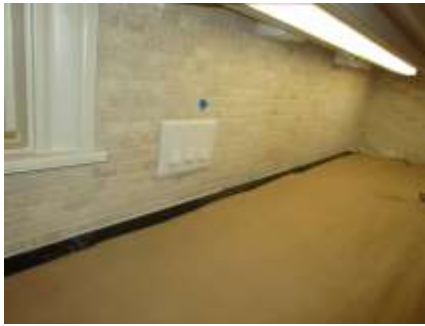
**Poor access to disposal switch**

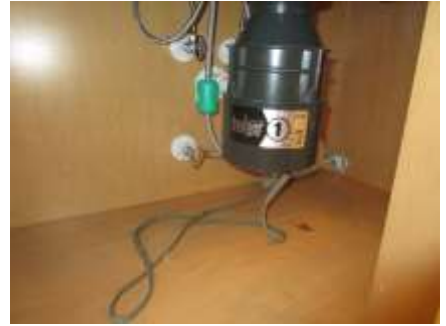
**Secure loose cord for disposal**

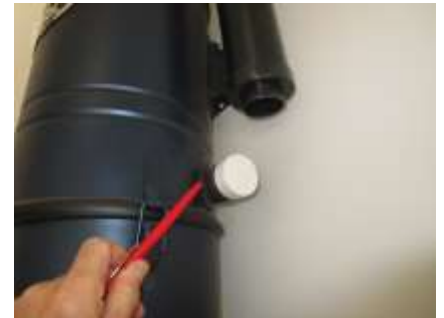
**Central vacuum system.** Can A Vac unit located in garage. (D) External exhaust not installed off of this unit to the exterior. One supply connection with cap on unit should be examined for installation of appropriate connector. Obtain all accessories for this appliance that were not available during this inspection process.

**No external exhaust and missing connection off unit**
