**ABLE INSPECTION  
COMPANY**  
*Inspecting Homes Since  
1976  
713 465-0000*

CLIENT: John Sample

DATE – October , 2018

INSPECTOR: Larry Malloy TREC 332

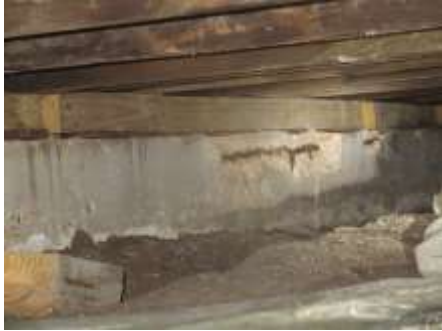
**Exposed rebar inside west concrete stem wall**

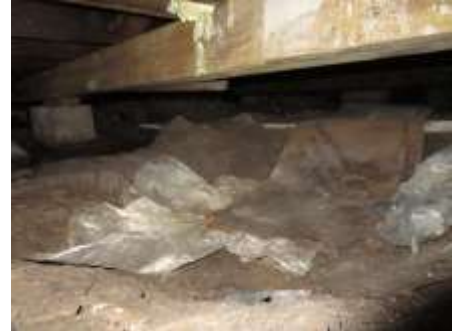
**Cardboard under house**

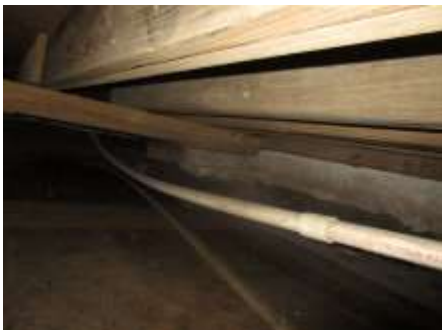
**Loose PVC piping under east house**

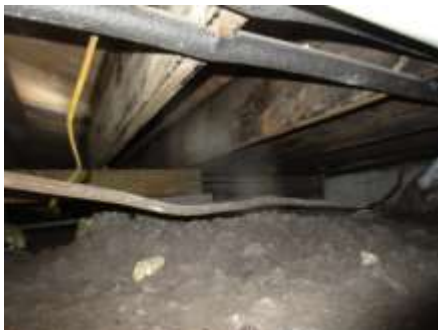
**Loose electric wires under house**

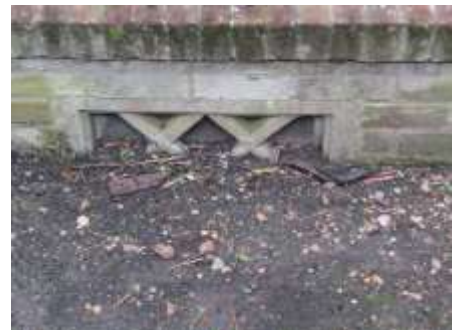
**High soils cover half of east vent**

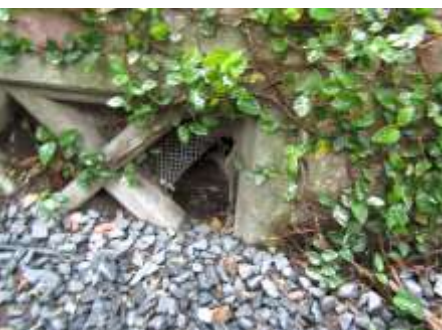
**Torn west vent screen**

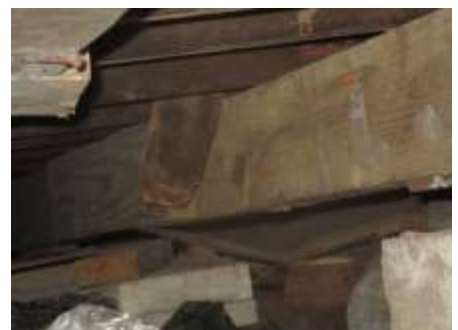
**Loose support under beam**

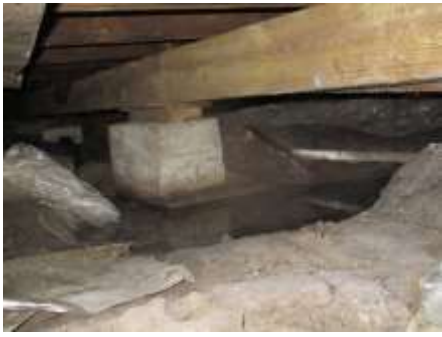
**Water under house**

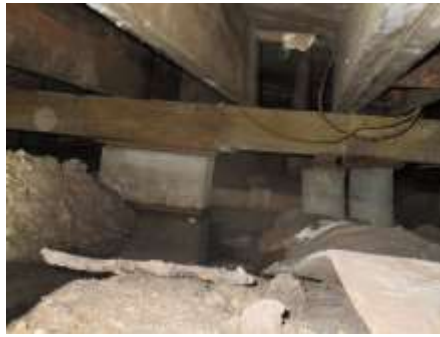
**Water under center crawl space**

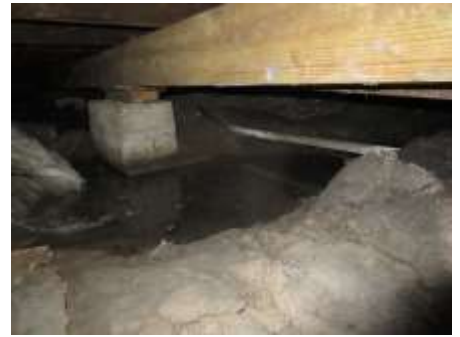
**Water under southeast side**

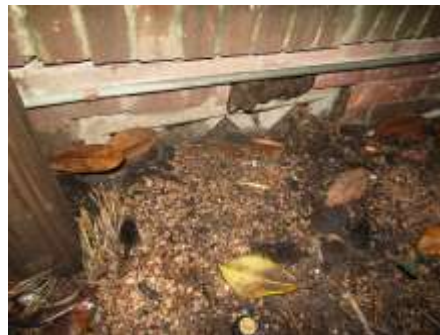
**Covered east foundation vent**

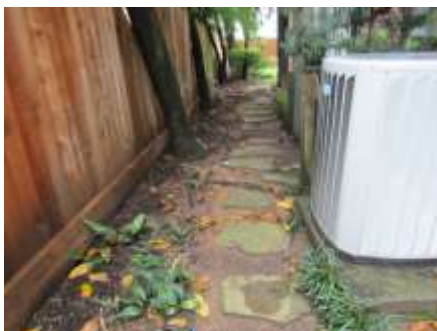
The exterior grade along the east side and rear residence and around garage is primarily flat. The natural grade has been raised almost to the lower brick and wood siding areas making it possible for accumulated surface water to enter this residence and garage through the brick and foundation vents and under wood siding around garage. This also represents poor drainage conditions for this foundation system.

**No area drains at east side**

We recommend that the buyer retain the services of a reputable and qualified landscaping and drainage expert to investigate the area around this residence/garage. They should provide specific recommendations on the installation of possible drain and water movement systems as well as make suggestions on improving the grading techniques to reduce the collection of rainwater and thereby reduce the possibility of water intrusion into this residence/garage.

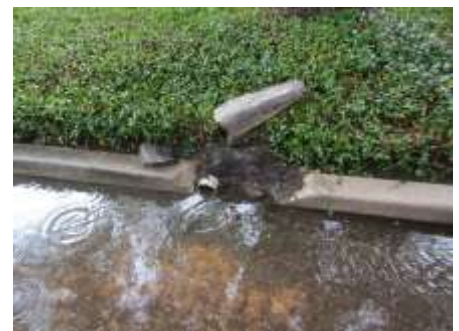
Able to locate random 12"x12" area surface drains at rear yard, driveway flatwork and additional 4" drains off of rain gutter discharge pipes, terminating at front northeast curb/street. Since it was raining at the time of inspection, some of these drains were restricted and clogged and not channeling rainwater adequately. In addition, curb broken around drain pipe termination.

**Clogged drain at curb and broken curb**

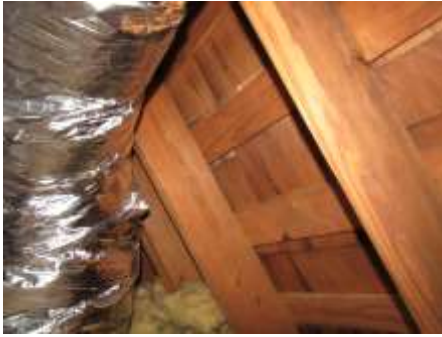
Wood shingles with roof overlay

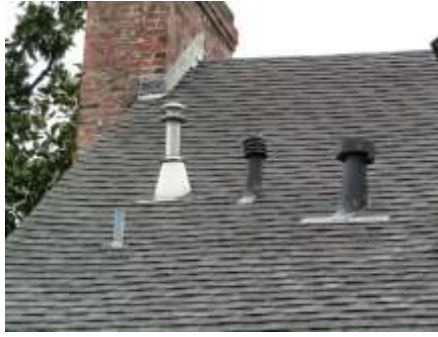
11. Gas vent pipe projections for existing or abandoned heaters located at upper northeast roof.

Gas vent pipe projections for previous or existing water heater(s)

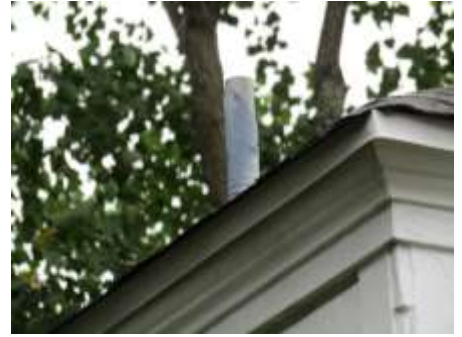
4. Damaged and compromised lead roof jacks from squirrels.
5. Pest proof exhaust vent type roof jacks with screening and/or equivalent.
6. Voids are located at the soffit/fascia and roof shingles intersections at random locations on front, side and rear areas and we suggest sealing/covering these openings to prevent water, wind and/or pest intrusion.

Damaged lead roof jack

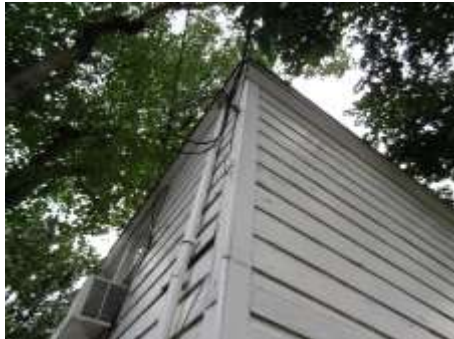
Tree branches on quarters roof

1. Remove the tree debris accumulation off of the roof and valleys, etc. to allow rainwater diversion (the condition of any covered roof material is unknown). Prune tree branches away from the roof to prevent damage to roofing material, rain gutters (if installed) and perimeter fascia material and to also reduce the opportunity for the infestation of pests, carpenter ants and other wood destroying insects.

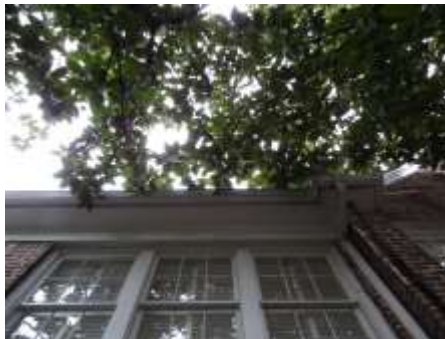
Tree branches at east roof

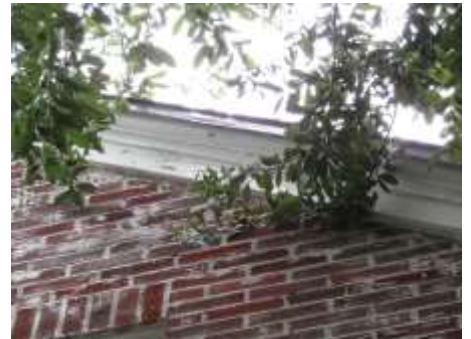
3. Damaged rake of shingles along east and west sides of residence from tree branches rubbing against roof (additional damages may be revealed when roof is accessed).

Tree branches and damaged shingles

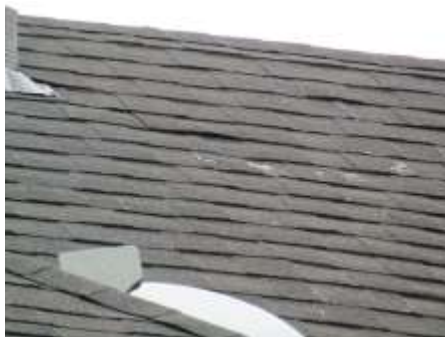
9. Worn shingles with loss of granules and exposed fiberglass matt due to aging of roof – this roof is in last stage of useful life expectancy and new buyer should option to retain proposals for replacement from reputable roofing contractors along with tightening up repairs.

Worn granules at upper rear shingles

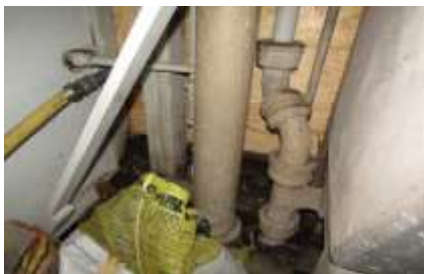
11. Several locations of daylight, voids, water intrusion and damages located in the separate garage building and side door. Due to the age of this building, absence of perimeter area surface drains and multiple obstructions from stored items, this building is considered **“as is”**.

**Daylight, water and damages in garage**

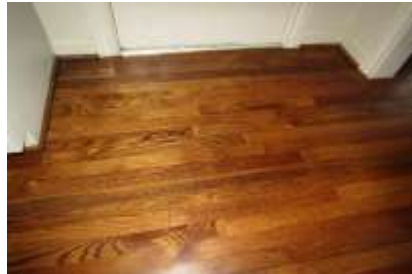
**Cupped hardwoods at west door**

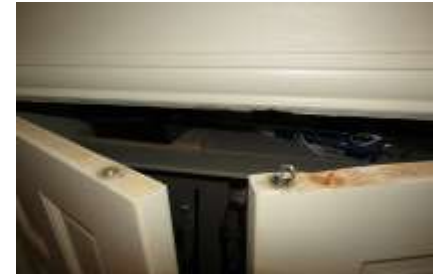
**Broken double door roller balls**

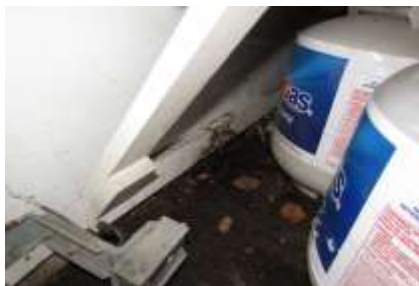
**Water inside garage**

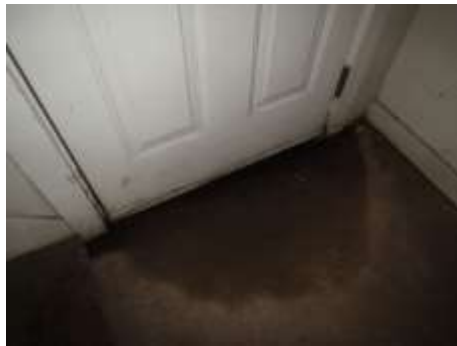
Water inside east quarters door

It is very important that a prudent buyer retain the services of a reputable and qualified contractor in the immediate future to determine the exact source of leaks, to examine all areas for hidden damages and to expose any possible mold/mildew and provide estimates for the appropriate repairs. Failure to respond to the conditions mentioned above, before the purchase of this property, commonly results in unanticipated, and often costly, repairs.

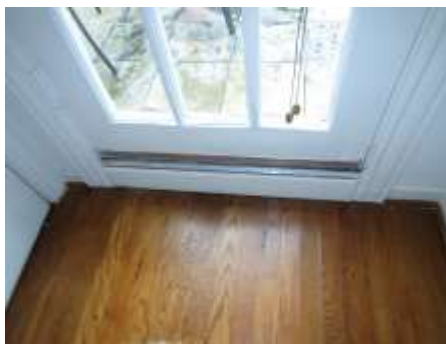
- (D)** Water intrusion inside the second level southwest balcony door and first level southeast exterior door (with damages).

Stains inside upper rear west balcony door

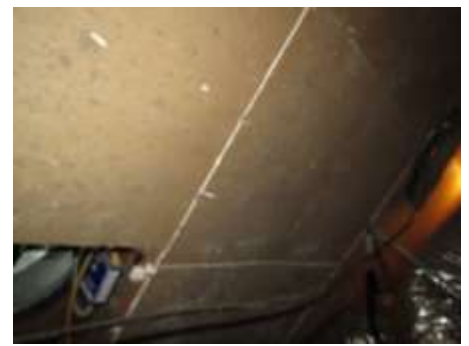
- (D)** Evidence of dry black organic matter (suspect mold) in third level attic on wall and ceiling sheathing material and the possibility of mold propagation on ceiling of master bedroom due to excessive accumulation of water that has occurred for some time.

Black organic substance in third level attic

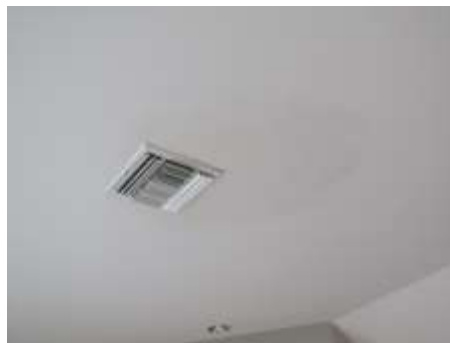
Wet master bedroom ceiling

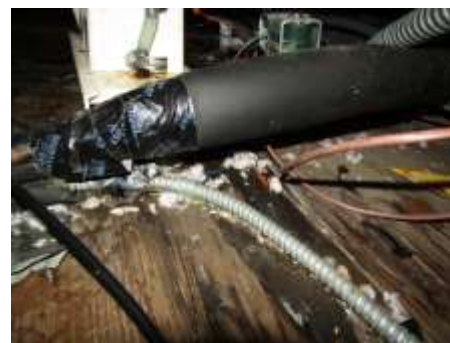
Water on attic deck from first level HVAC drain pump

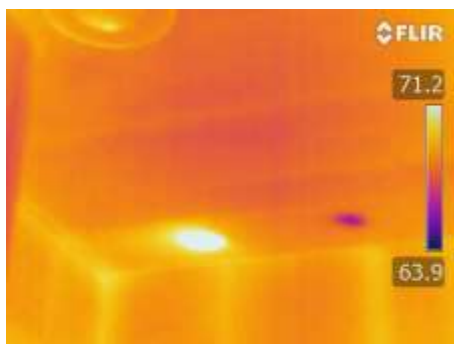
Water image on ceiling in master bathroom

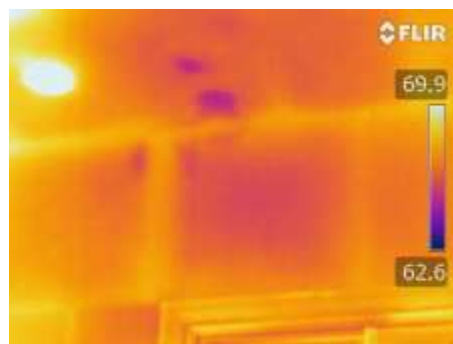
Water images on ceiling and wall of 2<sup>nd</sup> level north bathroom

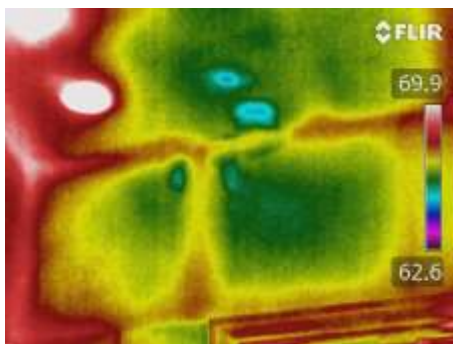
Water images on ceiling and wall of 2<sup>nd</sup> level north bathroom

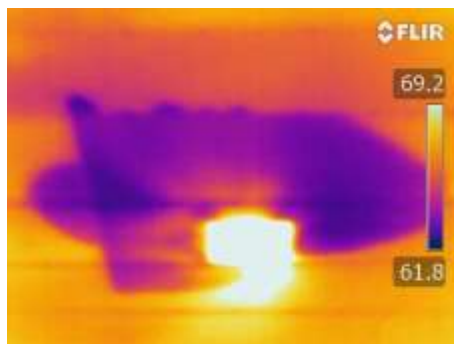
Water images on ceiling in Master bedroom

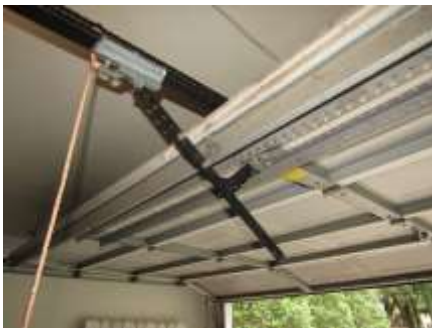
**Damaged top of garage overhead door panel**

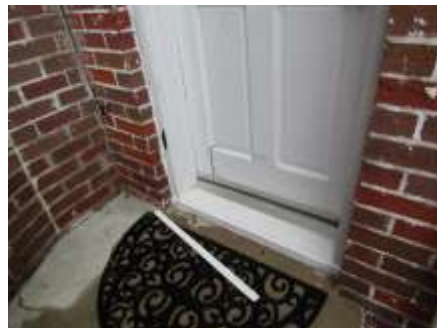
**Damaged rear door**

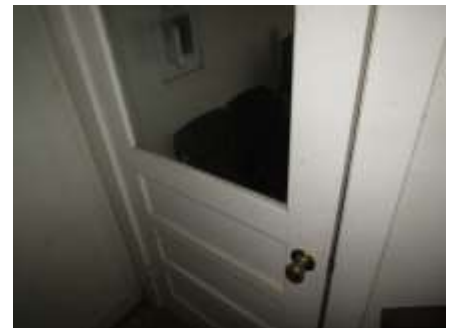
**Glazing not tempered at garage quarters**

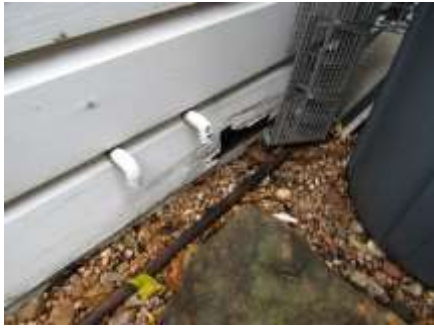
**Damaged wood at garage**

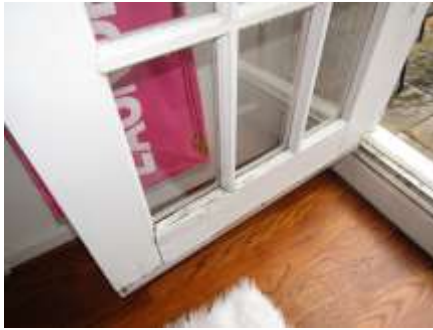
**Damaged upper balcony door and casing**

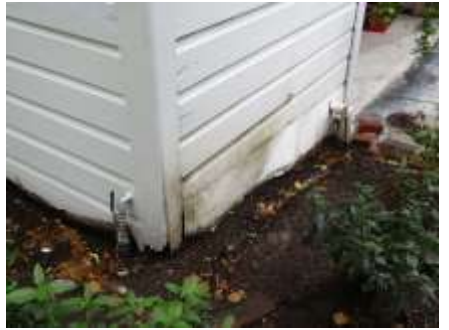
**Damaged siding and trim and metal flashing at front garage**

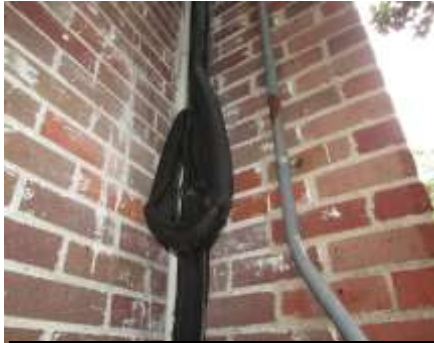
**Exposed refrigerant line and torn insulation**

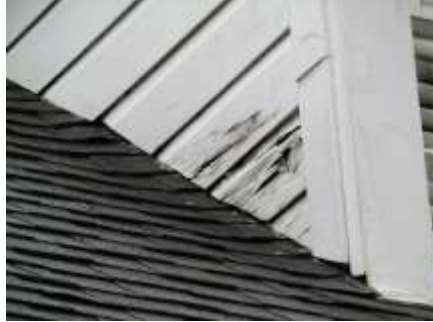
**Damaged wood off front dormers**

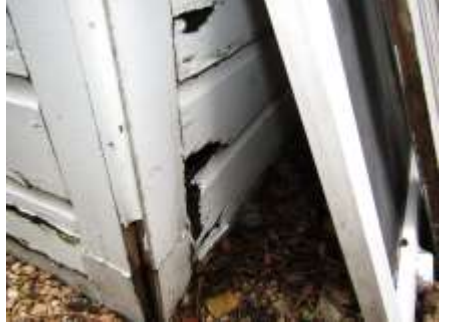
**Damaged wood at garage**

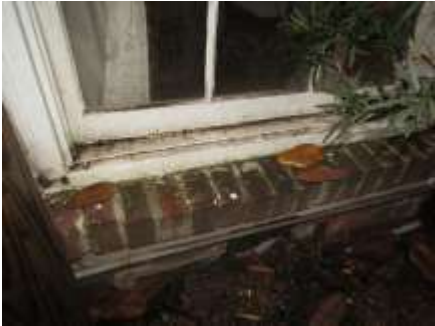
**Inverted east windowsill**

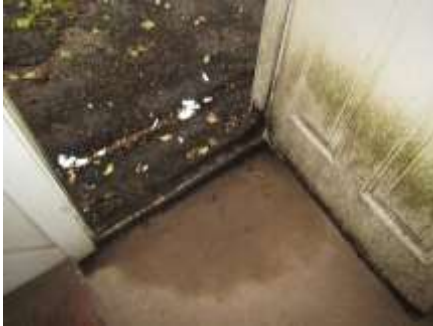
18. Some random slightly compromised and weathered exterior wood shutters.
19. High soils and damages at side quarters door.

**High soils and damages at side quarters door**

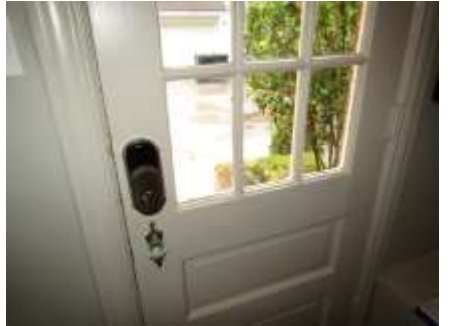
**Glazing not tempered at doors**

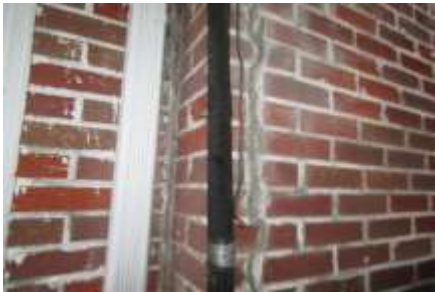
17. Slight displacement of first and second level northeast windows and brick with some brick cracks and previous repairs with some brick cracks along east side of house proper and addition.

**Previous repairs to brick and separation**

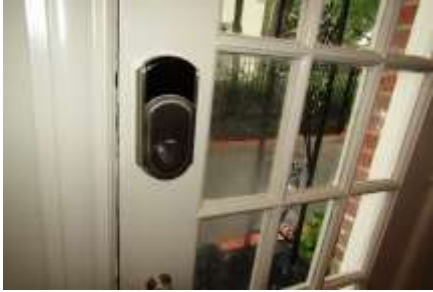
**Plexiglas on west side door**

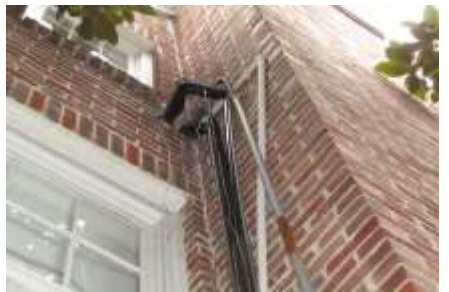
**Loose, exposed and rusted piping**

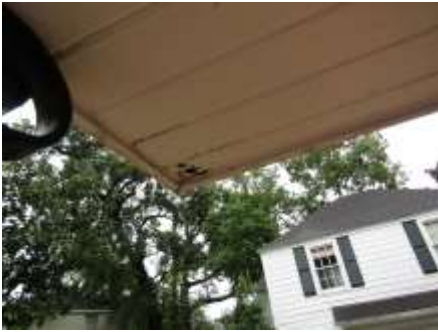
Rotted wood off rear south roof cover

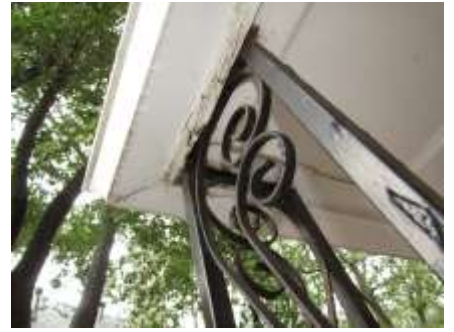
Rotted and damaged wood off west roof cover

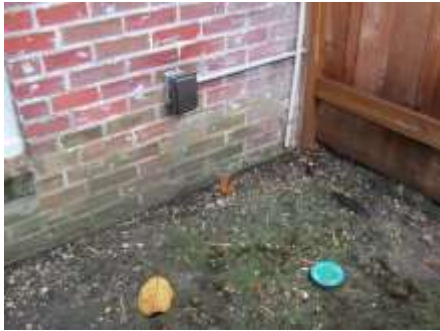
Stains and vegetation

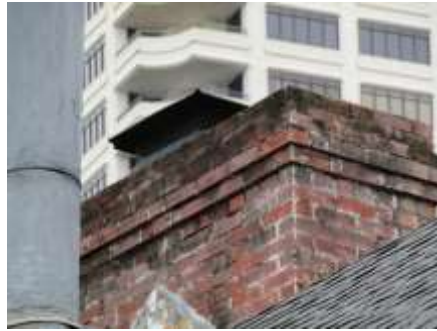
Stained brick off chimney

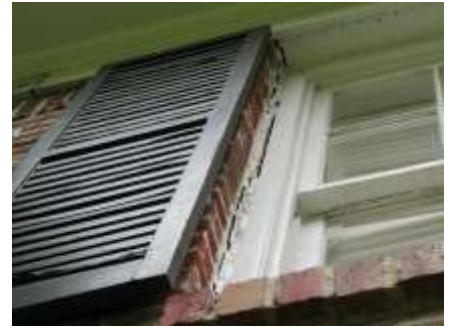
Separation of window and brick

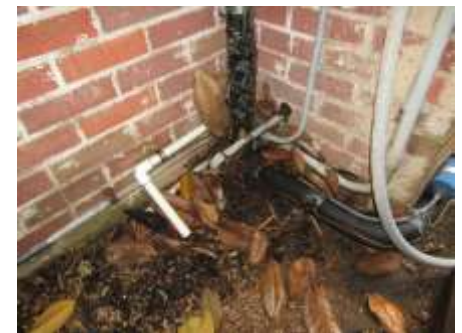
Rusted gas pipe and A/C drain termination

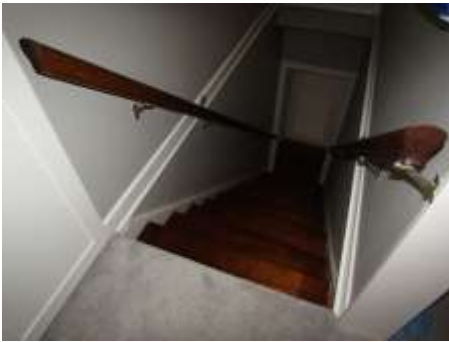
**(D)** The existing handrail in second to third level staircase is open-ended at the top and bottom of the stairs and should be closed into the wall to prevent the potential of entanglement with clothing, purses and backpacks, etc. when ascending and descending stairs. In addition, this staircase is narrow and some differential in the risers and handrail missing adequate gap at left and right sides of walls within close proximity of trim that will not allow fingers to pass due to original installation and care should be taken when ascending and descending these stairs.

(D) The existing handrail in quarters staircase is open-ended at the top and bottom of the stairs and should be closed into the wall to prevent the potential of entanglement with clothing, purses and backpacks, etc. when ascending and descending stairs. In addition, the risers have slight differential due to original installation.

Open ended rails

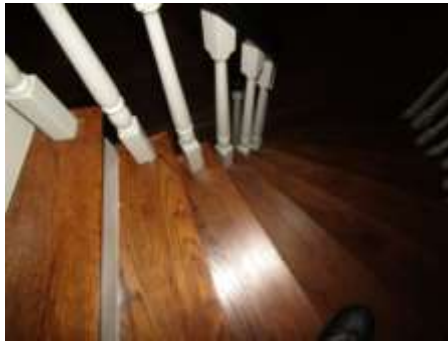
Narrow winders in stairs

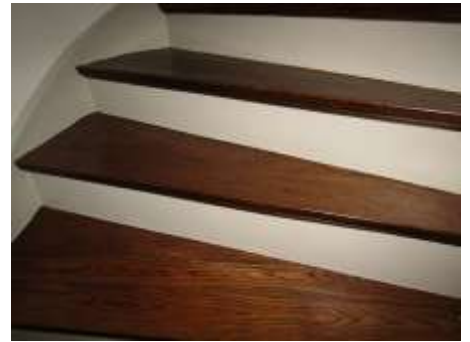
Curled treads on front stairs

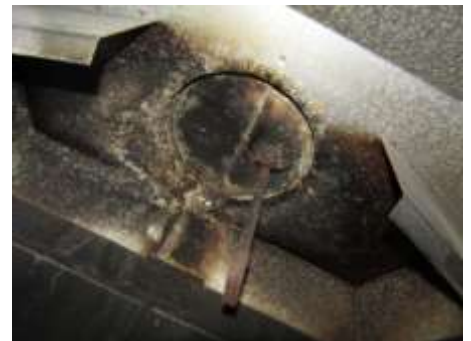
The hearth was a full width extension (18 inches). Prefabricated metal firebox unit with gas piping located in master bedroom. (D) Soot and creosote on damper and flue. Gas pipe has been capped in firebox and missing key for gas control valve – obtain information from seller on whether gas does function at this fireplace.

Rust and creosote at master fireplace

The metal and masonry caps were not accessible to view to determine its integrity and therefore could not be commented on. We recommend examination by reputable chimney contractors now and on an annual basis.

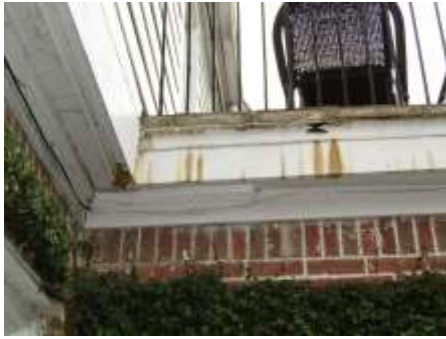
(D) Significant calcium water staining and leakage off of second level southwest open balcony with tile installation and consideration should be taken to obtain proposals from reputable tile deck contractors for thorough cleaning and sealant and/or upgrade replacement.

Calcium deposits off upper balcony

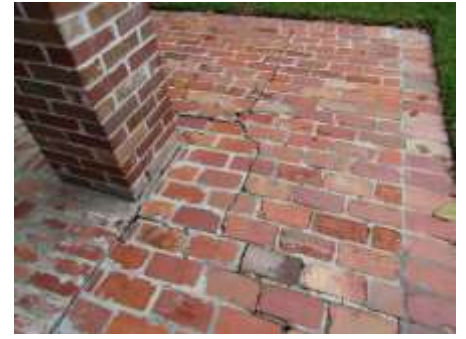
Broken rear east pavers

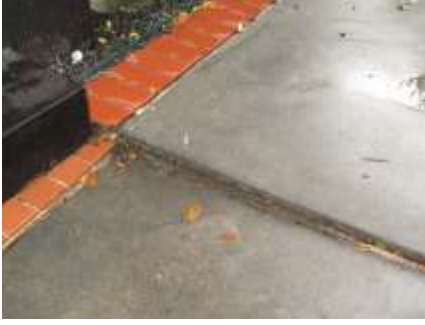
**Offset in driveway**

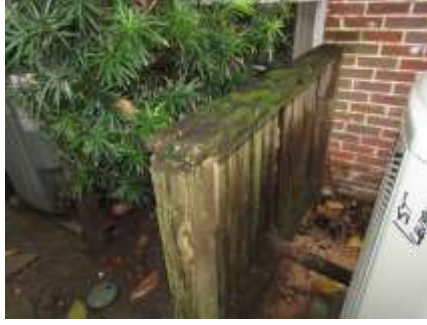
**Damaged east side fence**

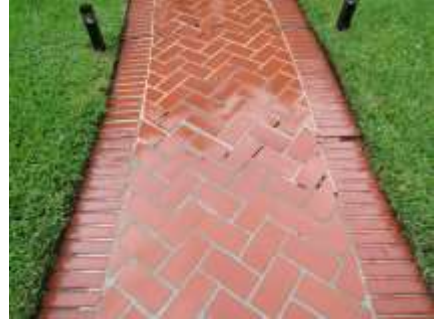
**Broken front walkway pavers**

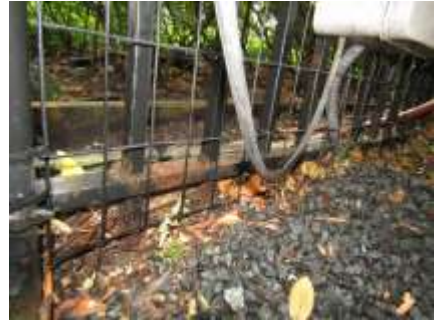
**Rusted lower fence and gate**
