**ABLE INSPECTION  
COMPANY**  
*Inspecting New Homes  
Since 1976  
713 465-0000*

CLIENT: Joan Sample

DATE – August , 2018

INSPECTOR: Larry Malloy TREC 332

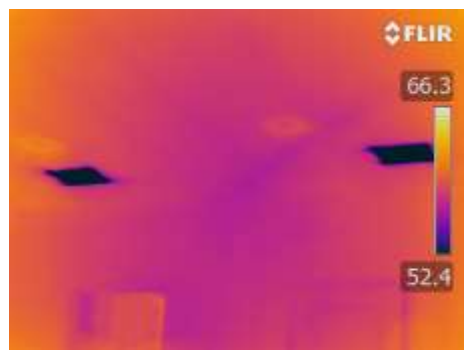
No anomalies on ceiling with HVAC cool air in operation

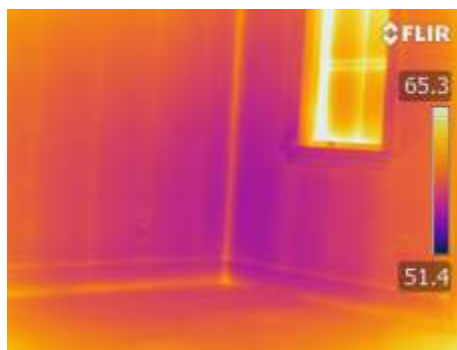
No anomalies in walls of bedroom

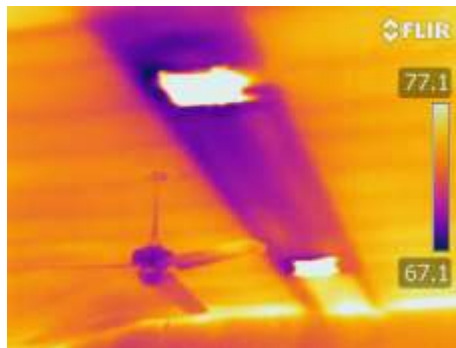
Heat images from heater mode in operation

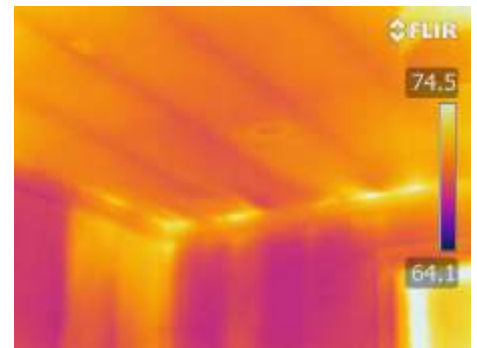
No anomalies on 3<sup>rd</sup> level ceiling

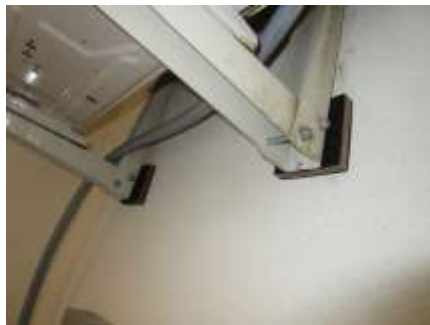
**Poor installation of HVAC unit on stucco wall**

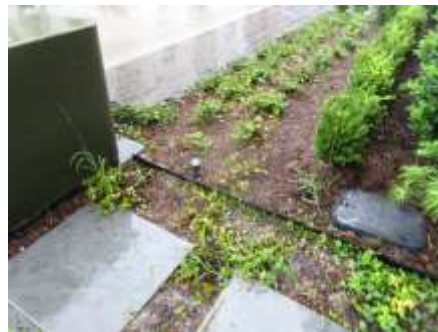
**Poor passage to west side of home**

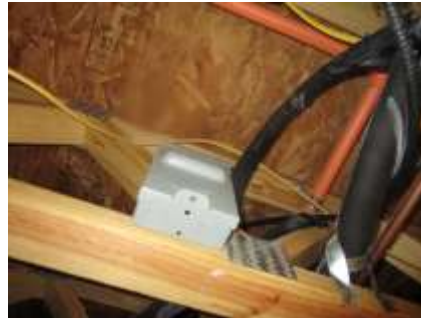
Five zoned LG heat pump units located in ceilings at first, second and third level locations with electric disconnect on second level HVAC unit. **(D)** Disconnects not installed on all other four units. Exposed cable wires off first level south HVAC.

**Only one disconnect on second level HVAC**

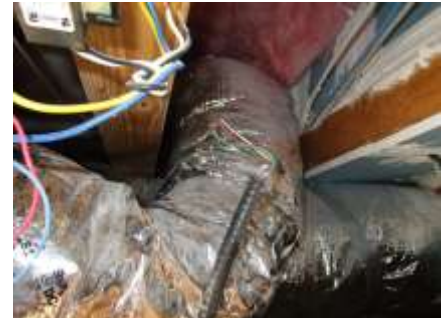
**Exposed cable wires off first level south HVAC**

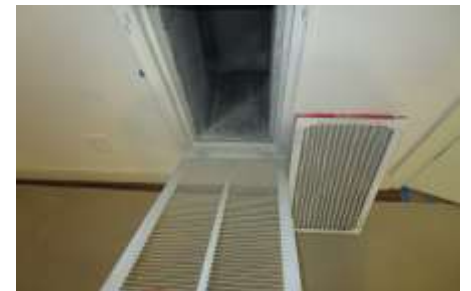
**(D)** Replace filters at all locations. It was understood that second level return air duct of 12" is undersized and suggest consulting with LG trade that specializes in this equipment for their specific recommendations on function and integrity of return and supply air to these units. Possibly undersized return air for master HVAC.

**Possible undersized return air for master HVAC**

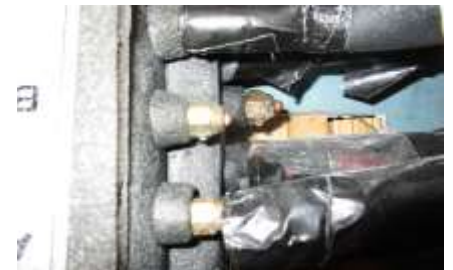
**(D)** Condensation dripping off of second level manifold in hallway closet wall from missing adequate insulation.

**Missing insulation on second level manifold**

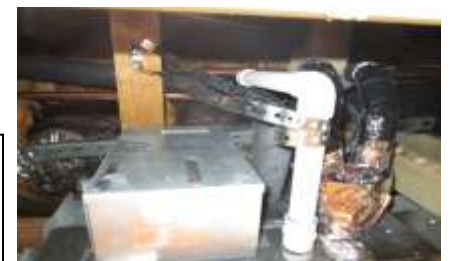
Visibly **OP** These drains should also be cleared and flushed with Spring and Summer season operation. Odd emergency drain installation off HVAC units in ceilings.

**Odd emergency drain installation off HVAC units in ceilings**

Float devices are not installed on auxiliary and/or primary drains.

Drain lines are installed into lavatory plumbing drains, which may result into a drip/air noise. An HVAC contractor, of your choice, can improve the modification of the drain line in the attic.

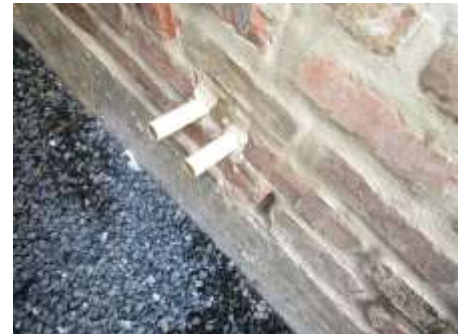
DRAIN PIPE: CPVC type. (D) Missing elbow with long piping extension at exterior southwest wall.

Trim long drain pipes and install  
ells

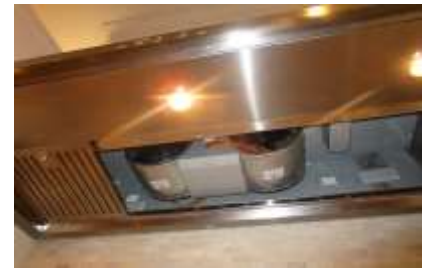
Thermador overhead type with make up air vent unit. Visibly **OP**, however, noisy operation of unit in "high speed".

**Excess noise off overhead vent in high speed**

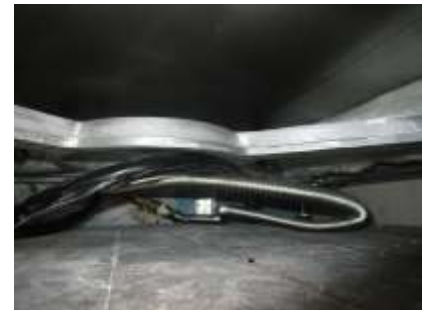
Thermador gas type. Operative during inspection, however, limited accessibility to gas stop valve under this appliance.

**Limited access to range gas stop valve**

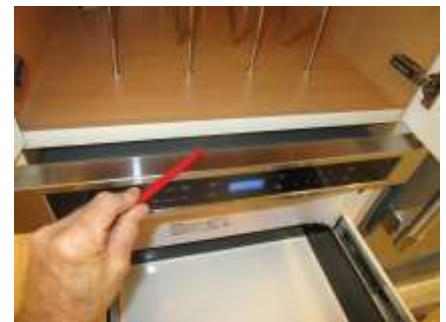
Thermador type. **(D)** Not mounted into cabinet.

**Loose microwave in cabinet**

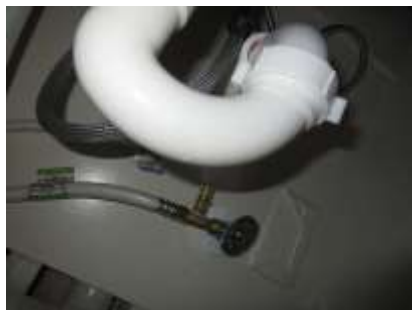
ICE MAKER: Kitchen Aid type located in third level wet bar. **(D)** Not connected during inspection and may be connected to hot water supply piping and this appliance must be installed with separate stop valve from cold supply.

Third level dishwasher and ice maker on hot piping and no separate stops

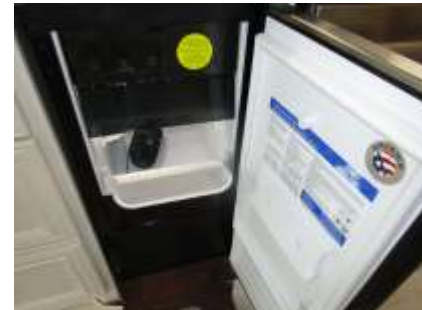
Third level ice maker not in start up mode

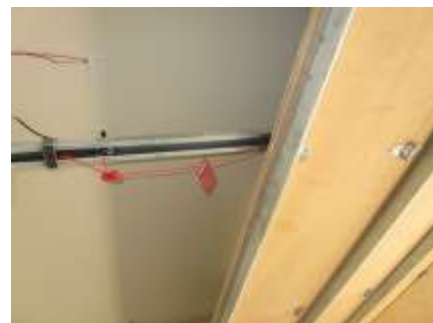
**G.** GARAGE DOOR OPERATOR: Marantek belt drive type unit with safety sensors on lower rails. **(D)** Not connected during inspection to the door.

Garage door operator not connected

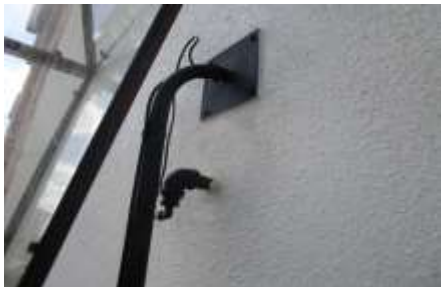
**Gas lanterns.** Two located at front exterior. **(D)** Not lit during inspection and stop valves not located for these lanterns.

**Gas stops unknown**
