**ABLE INSPECTION  
COMPANY**  
*Inspecting Homes Since  
1976  
713 465-0000*

CLIENT: John Sample

DATE – October , 2018

INSPECTOR: Larry Malloy TREC 332

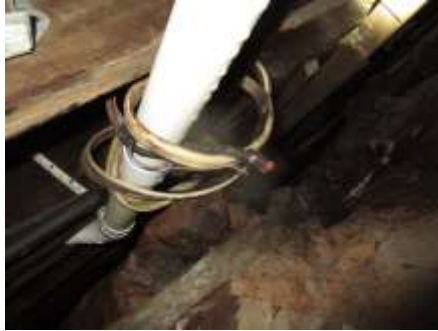
**Exposed and energized electric cables**

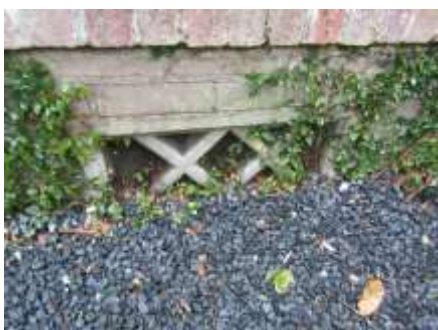
**Low west vent and ivy over screen**

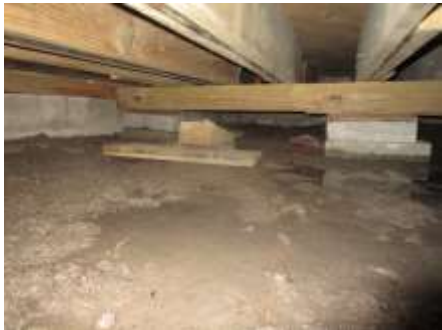
**Wood debris under east house**

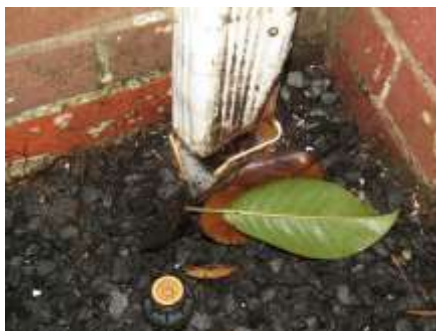
**Clogged rear east gutter drain**

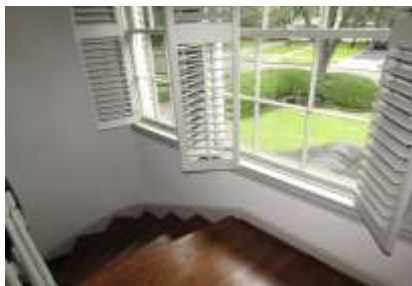
**Glazing not tempered at stairs**

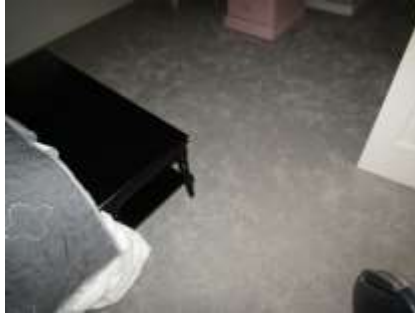
**Squeaking sub flooring**

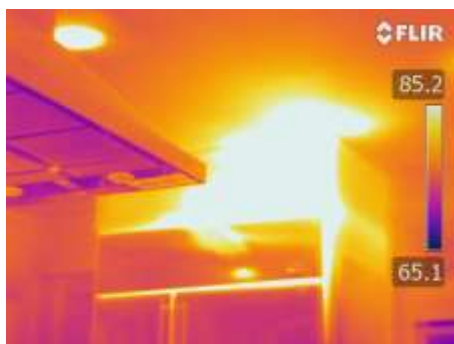
Typical image of heat off refrigerator unit in kitchen

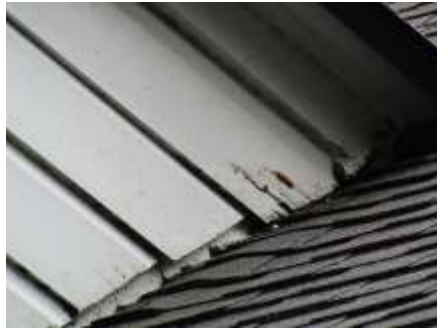
Rotted wood at front upper dormers
