**ABLE INSPECTIONS**  
*Inspecting Commercial Buildings Since 1976*  
**713 465-0000**

**CLIENT:** Judy Sample

Houston, TX

## **COMMERCIAL BUILDING DESCRIPTION w/FRONT OFFICE AND REAR WAREHOUSE ATTACHMENT**

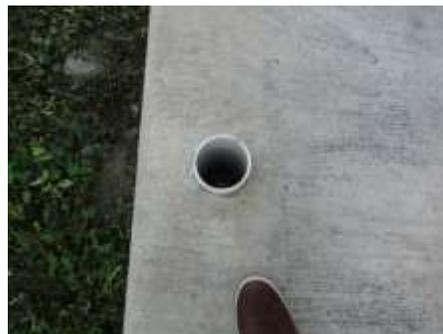
**(D)** Open and unused 4" drain pipe at west side flatwork,

**Open and unused 4" drain pipe at west side flatwork**

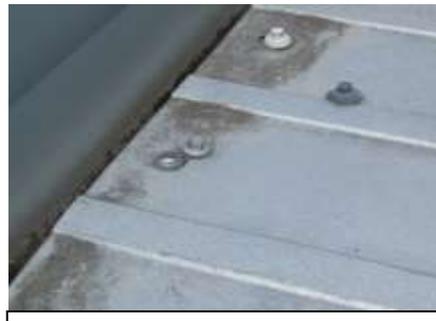
**Seal unused hole in southwest roof panel**

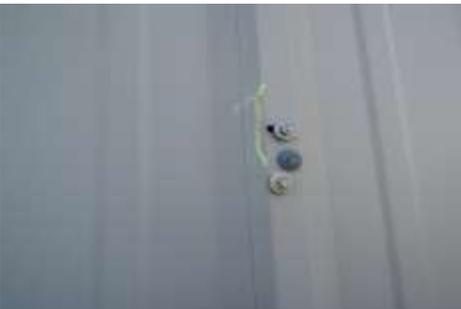
**Seal open holes in west siding**

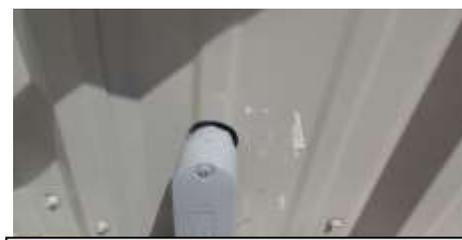
**Seal front electrical LB into wall panel**

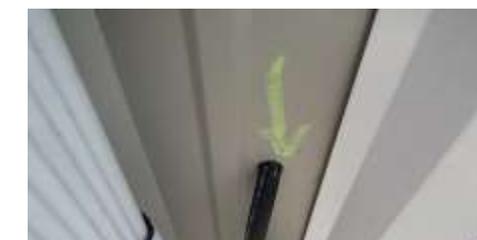
**Seal bond wire cable in west siding**

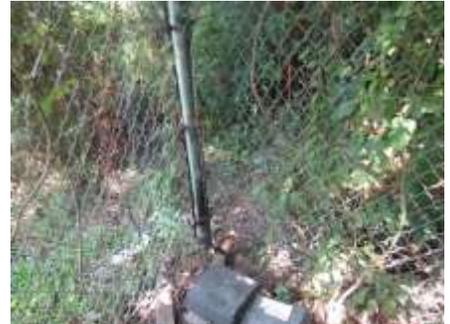
Cut rear northwest fence

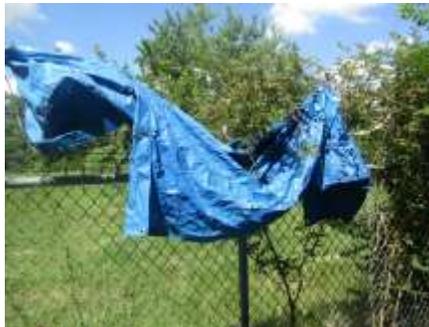
Plastic over fence razor wire

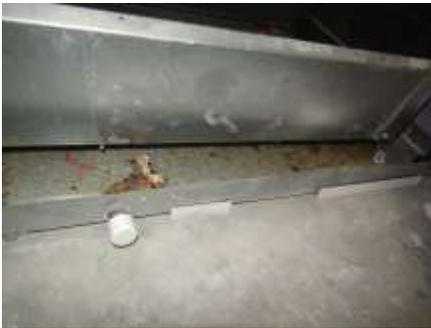
**(D)** Clean debris in all emergency pans left behind by HVAC trade. Water in emergency pan at east office unit. Drain lines not installed off of emergency pans, however, utilizing float switch disconnects.

**No drain installation off pan**

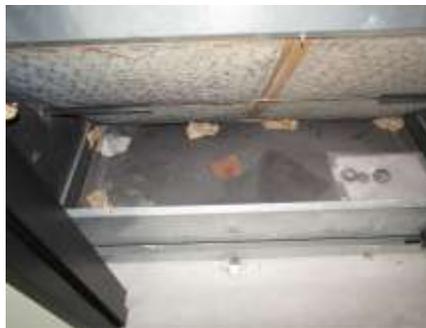
**Debris in second level office HVAC pan**

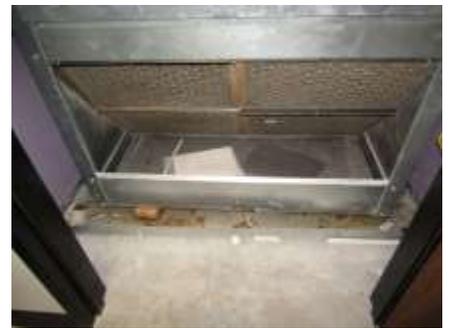
**Debris and water in east office HVAC pan**

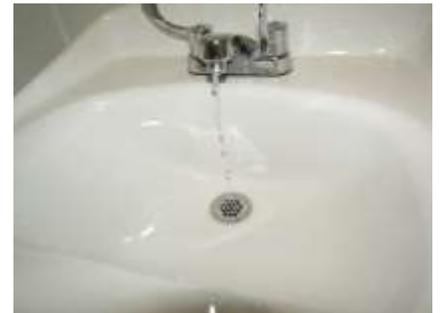
- a) Lavatory **(D)** The aerator on this fixture spout is clogged and is restricting positive flow (remove and clean out debris). Weak water pressure at office Womens lavatory.

**Weak water pressure at office Women's lavatory**

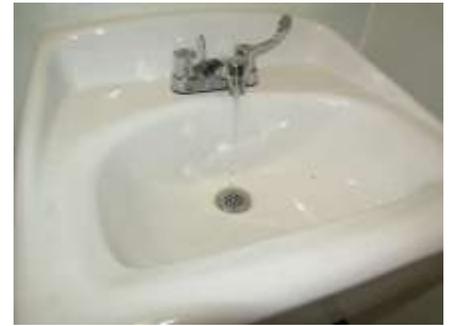
(D) The aerator on this fixture spout is clogged and is restricting positive flow (remove and clean out debris). Weak water pressure.

**Weak water pressure in second level Men's lavatory**
