**ABLE INSPECTIONS**  
*Inspecting Commercial Buildings Since 1976*  
**713 465-0000**

**PROPERTY INSPECTED:**  
Houston, TX

## **COMMERCIAL BUILDING DESCRIPTION w/FRONT OFFICES and REAR WAREHOUSES w/TWO BAY DOORS**

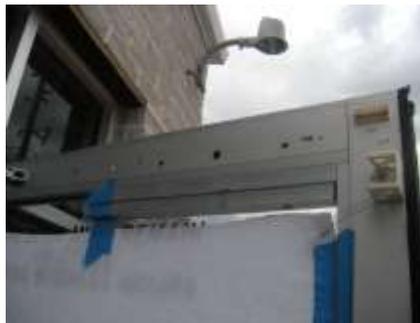
**Holes in front door**

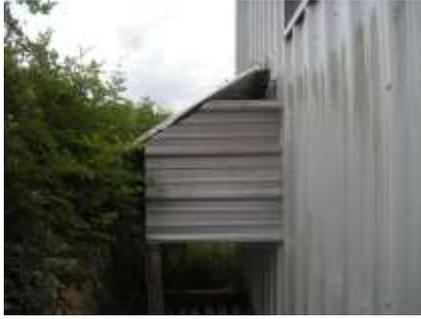
**Old shed cover**

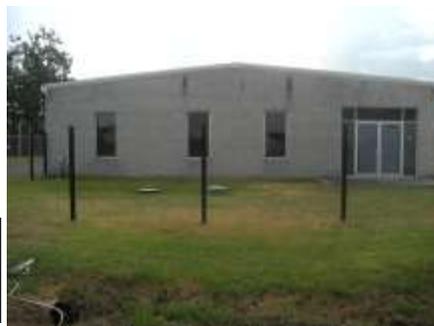
**Incomplete front fencing**

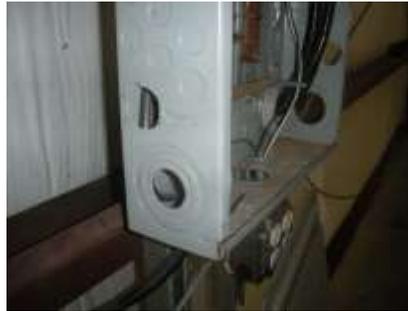
ITE copper panel box located in warehouse with additional sub panel at rear warehouse. **(D)** All breakers for the panel boxes and/or sub panels must be clearly and permanently labeled for identification of its particular circuit. Several open knock outs in panel with voids in dead front cover. Cover not installed over breakers at rear warehouse panel. All breakers for the panel boxes and/or sub panels must be clearly and permanently labeled for identification of its particular circuit.

Voids at interior panel

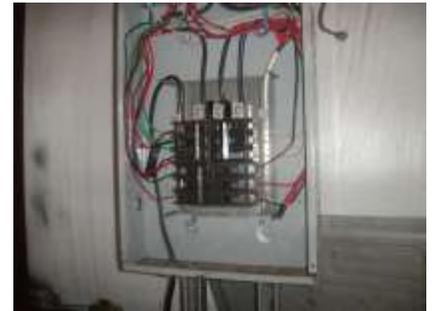
Cover off rear warehouse dead front cover

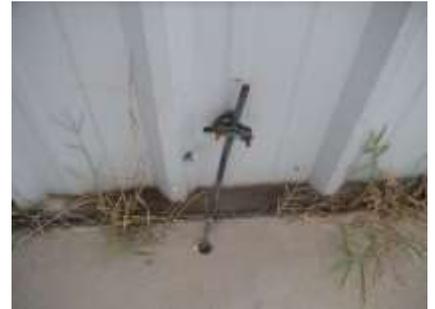
Earth ground not driven flush to grade and old clamp
