**ABLE INSPECTION  
COMPANY**  
*Inspecting Homes Since  
1976  
713 465-0000*

CLIENT: John Sample

DATE – October , 2018

INSPECTOR: Larry Malloy TREC 332

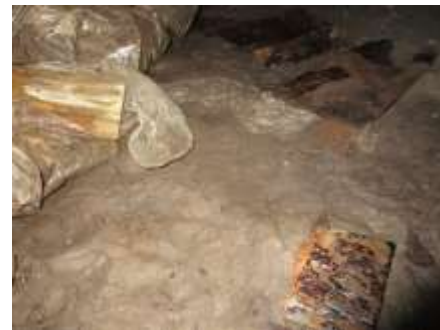
**Wet cardboard and plastic at west access**

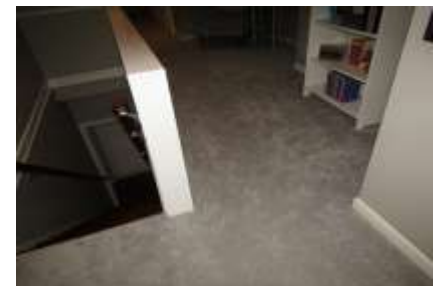
**Squeaking third level sub flooring**
